**1261 Harrison Street**  
**Category II Demolition Findings**  
October 2017

Appendix C

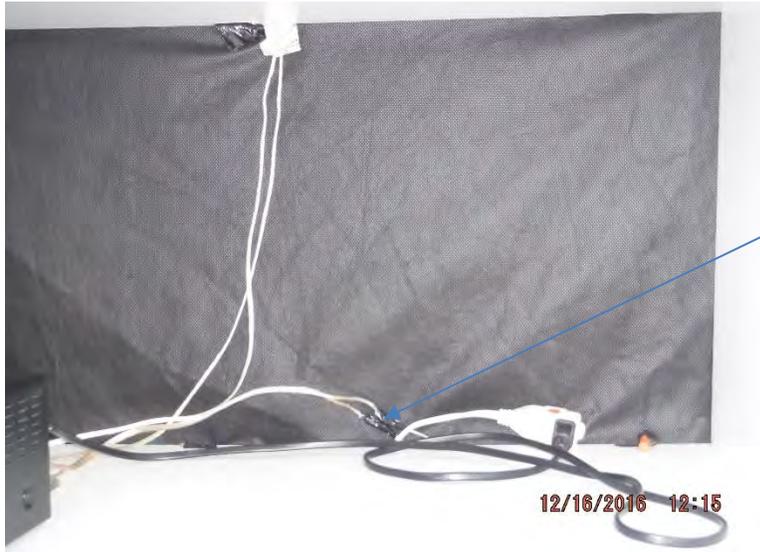
Interior Unit 333

Unsafe Electrical  
Splice

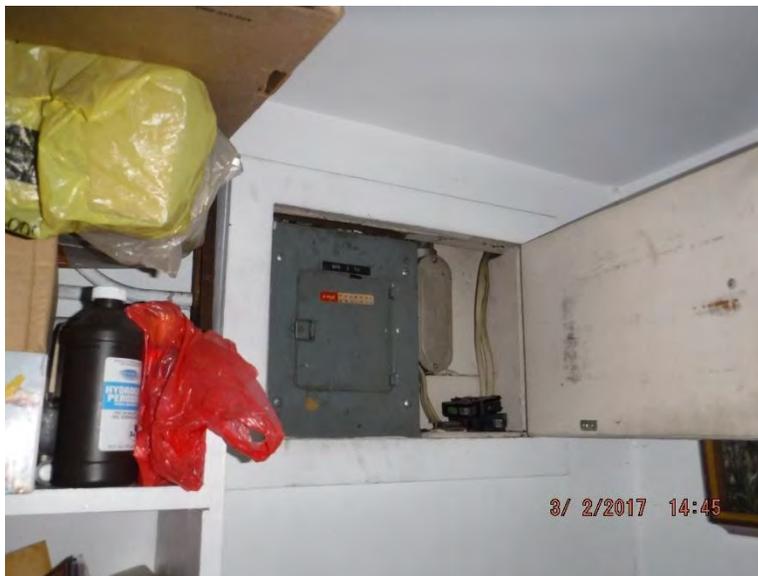
Unit 1269 – Federal Pacific Panel and Unsafe Modifications – Upstairs Office

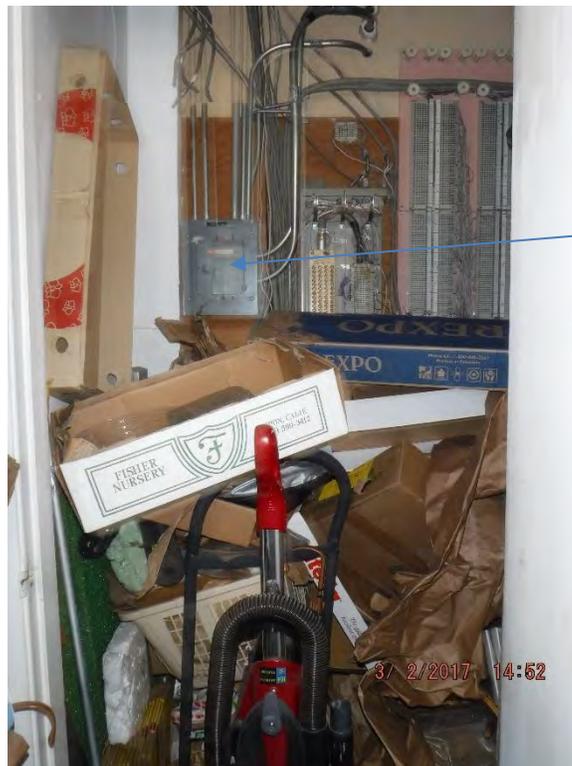
Modified Fed  
Pacific Panel

Unit 1269 – Closet at Front with Modified Electrical Box

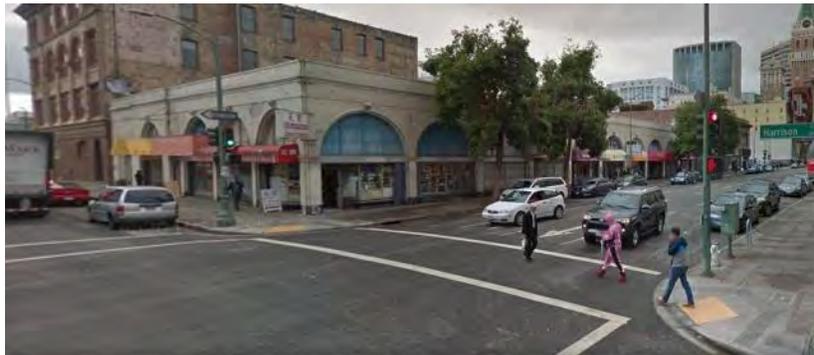
The building at 1261 Harrison Street, Oakland, California is a single-story unreinforced masonry bearing wall building with wood floors and roof. It is presently divided into a series of individual commercial occupancies. Figure 1 is a photo of this building.

**Figure 1: 1261 Harrison Street as viewed from the corner of Harrison and 13<sup>th</sup> Street**

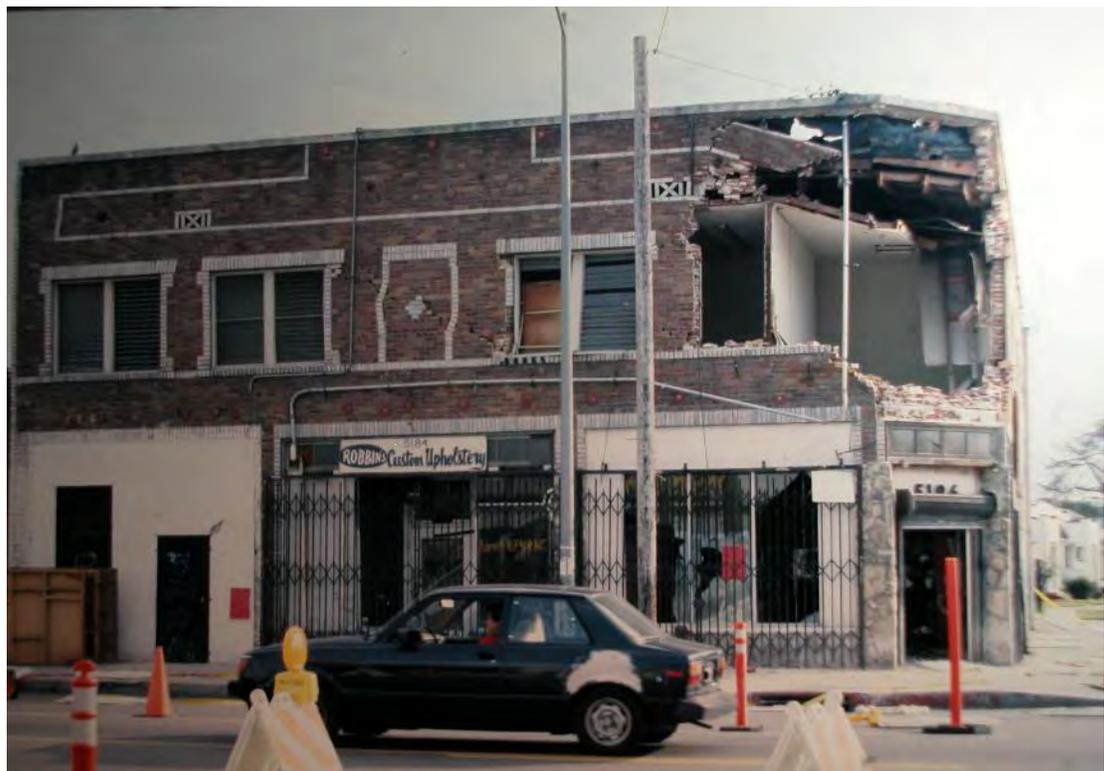
brick masonry wall panels “blow-out” from the building because they have inadequate strength. Figure 4 shows such a failure in a building in Culver City, California. If the walls have adequate strength to resist out-of-plane forces, and are adequately anchored to the structures, they may fail in shear due to in-plane forces, which can in turn result in collapse of the wall. Figure 5 shows such failures in a building in Santa Cruz, California, following the 1989 Loma Prieta earthquake. In other cases, the floors and roofs that tie the building together have inadequate strength and stiffness, allowing total collapse to occur. Figure 6 shows such a failure that occurred in the 1933 Long Beach, CA earthquake.

**Figure 4: Blow-out failure of wall in building in Culver City, CA, 1994 Northridge earthquake**

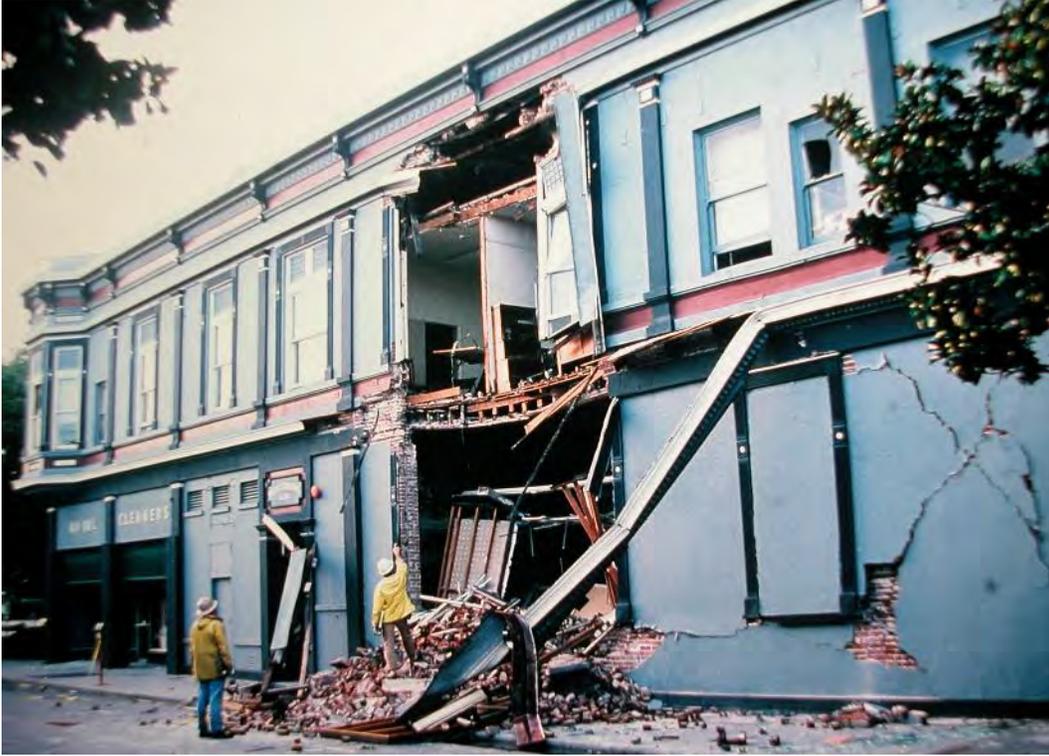
**Figure 5: In-plane shear failure of masonry building in Santa Cruz, California, 1989 Loma Prieta earthquake**

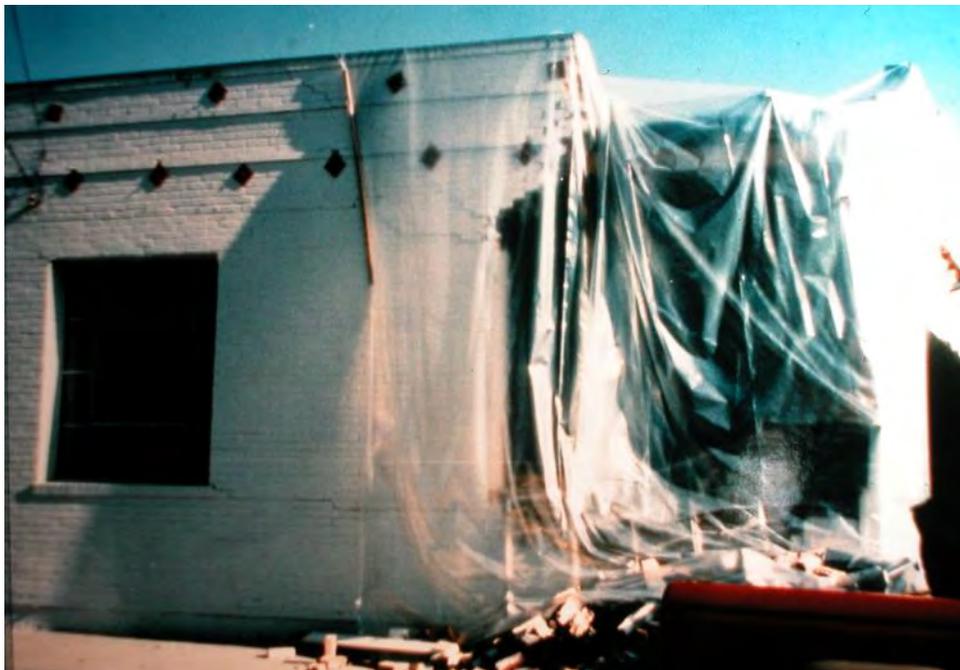
**Figure 8: Failure of retrofitted building, 1994 Northridge earthquake**

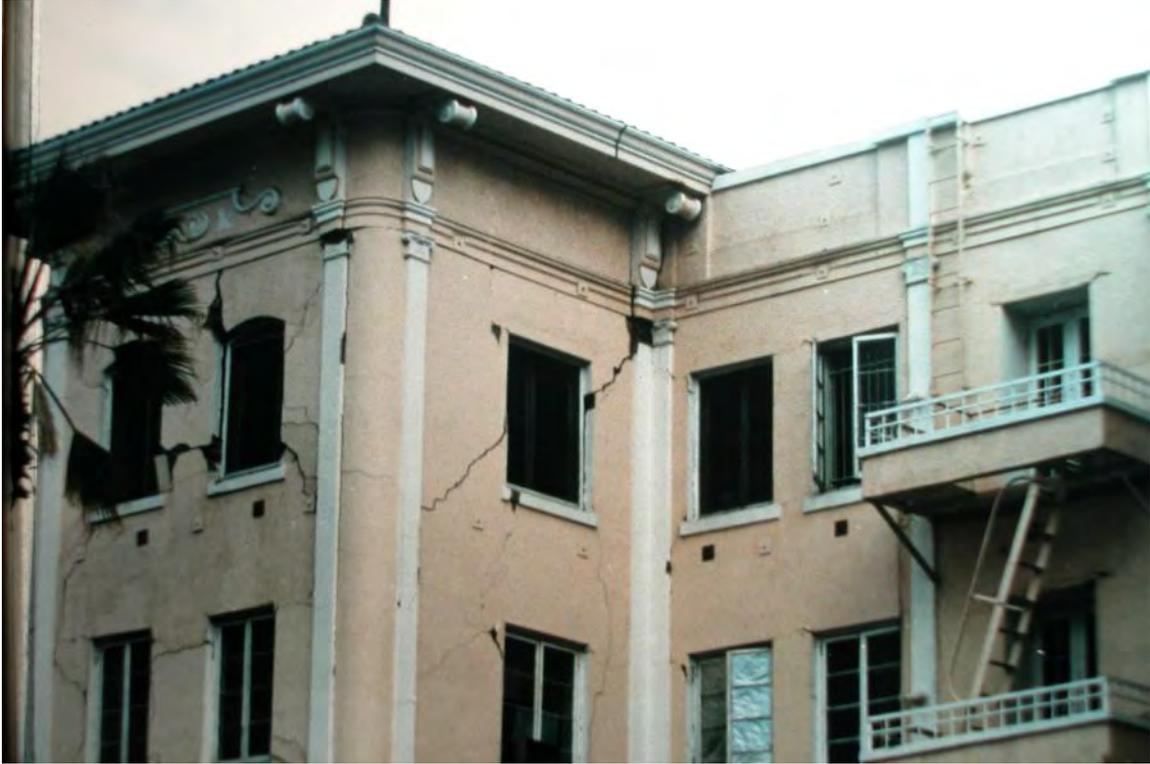
**Figure 9: Damaged apartment building in Hollywood, CA, 1994 Northridge earthquake**

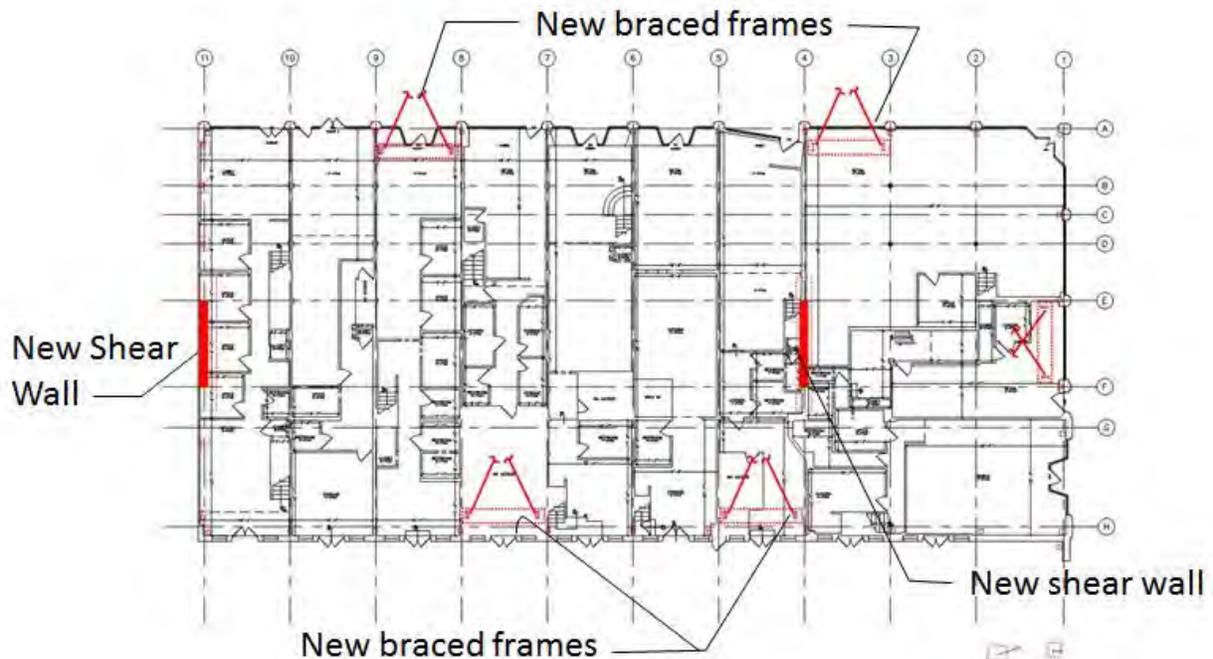
Figure 15: Ground Level Retrofit Structural Members

As indicated in the previous section, our evaluation indicates that the building does not meet standards for earthquake resistance specified by applicable seismic safety standards. Although the building has been subjected to a retrofit to bring it into compliance with an ordinance adopted by the City of Oakland in 1993, it remains a substantial earthquake hazard. The following sections describe our recommended strengthening measures to bring the building into compliance with these standards. Figures 15, 16 and 17 below, show the locations of recommended strengthening measures. Appendix B contains schematic level plans and details more fully describing these measures.

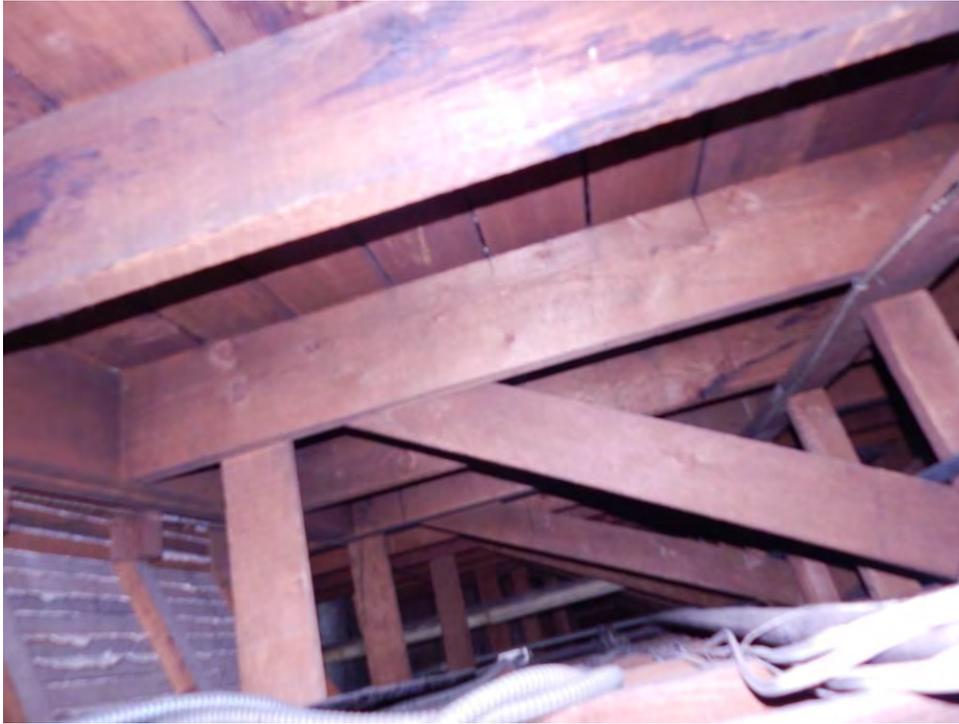
**Photo 7**

There are two small openings in the ceiling where we observed small areas of ceiling and roof framing.

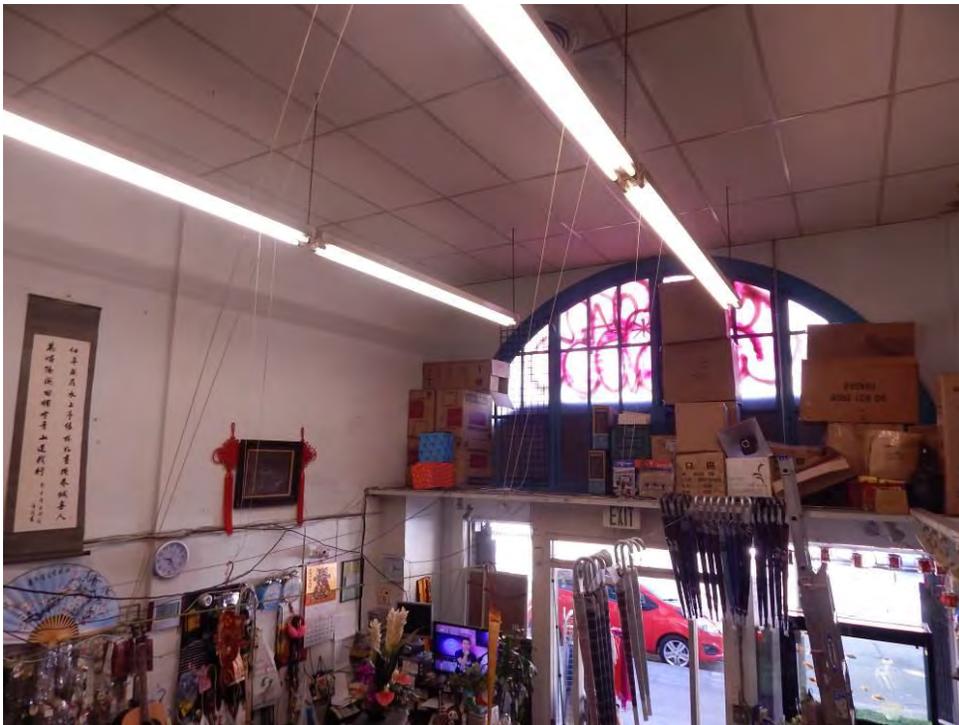
**Photo 8**

There are several stores that have a secondary T-bar ceiling in addition to original sheathed ceiling.
