**DRAFT PHASE 1**

**ENVIRONMENTAL SITE ASSESSMENT REPORT**

**Subject: Draft Phase I Environmental Site Assessment Report  
Children's Hospital & Research Center of Oakland  
747 52nd Street  
Oakland, California**

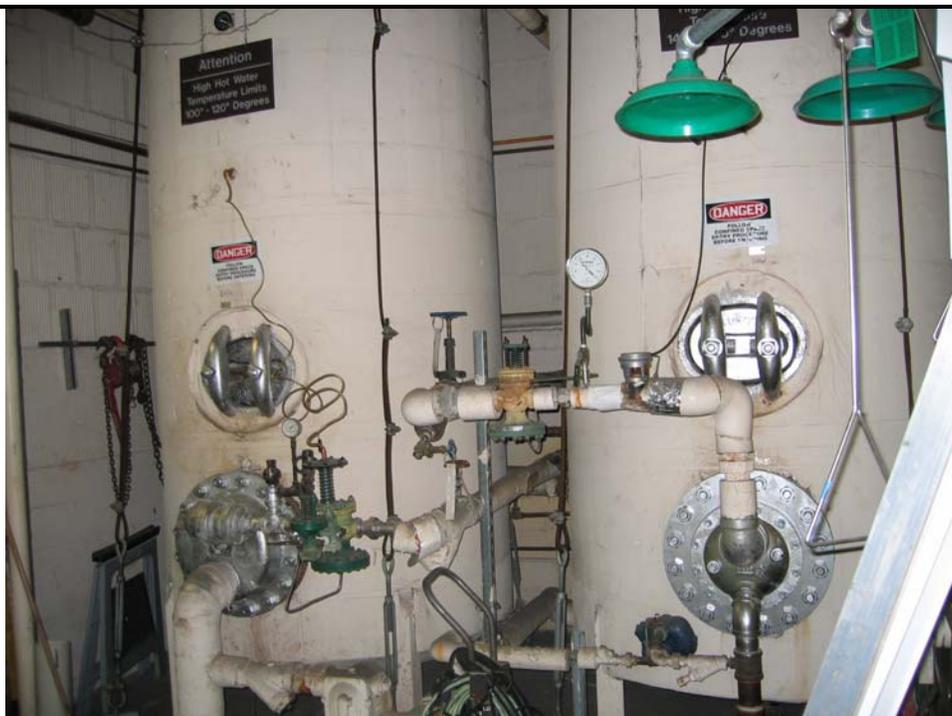
**Photograph 8:** *View of boilers located in the engineering room.*

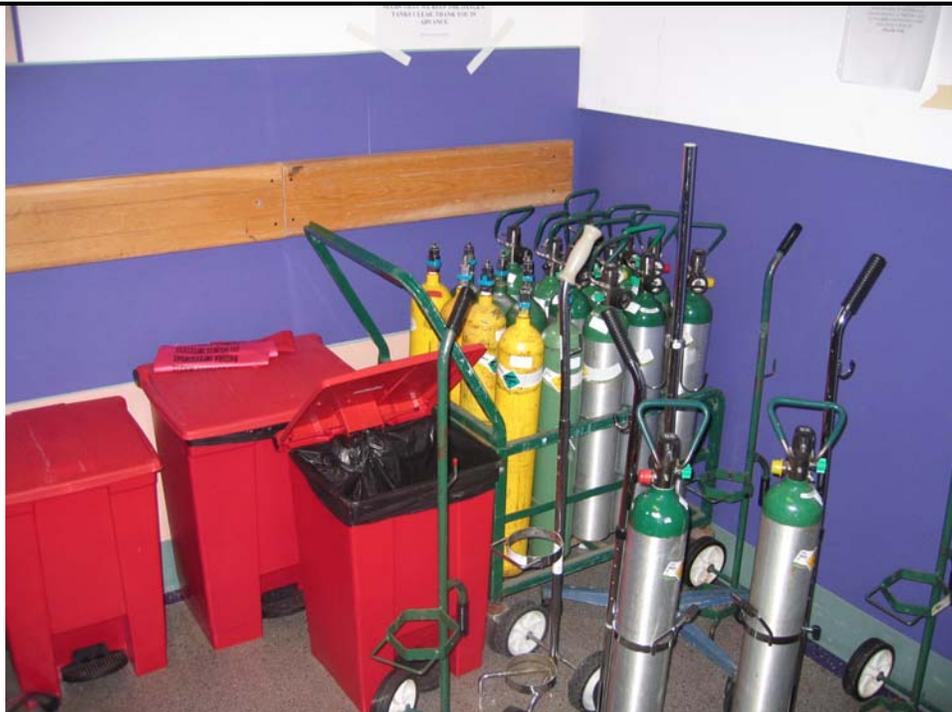
**Photograph 10:** View of oxygen cylinders located in a biohazard waste storage room located in the main hospital building.

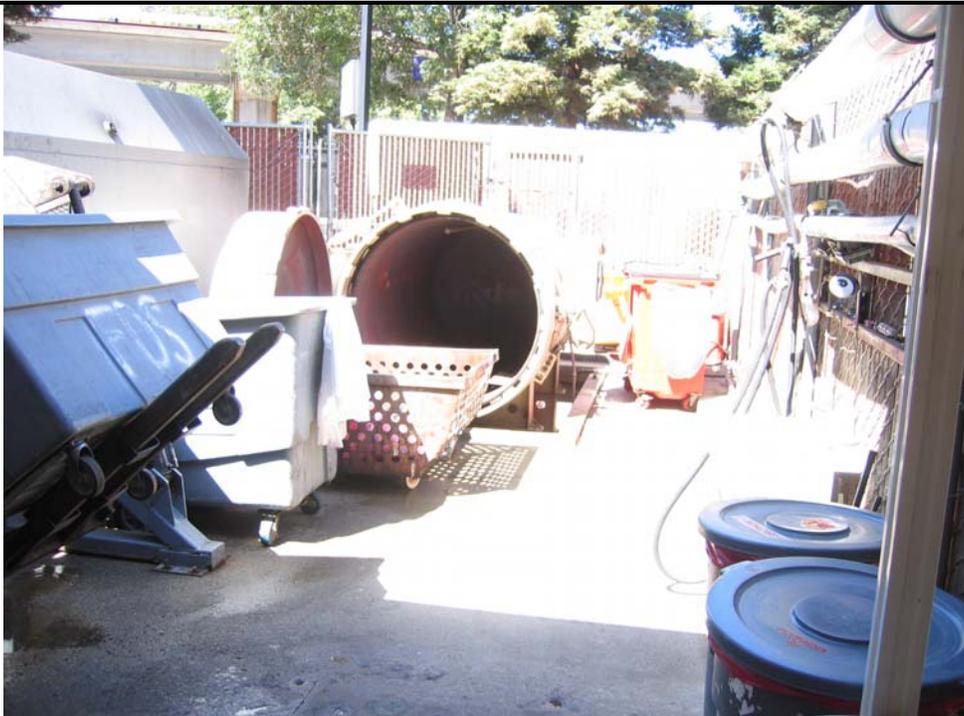
**Photograph 12:** View of the biohazard waste disposal area. Note autoclave oven in the background and dumpster in the left foreground.

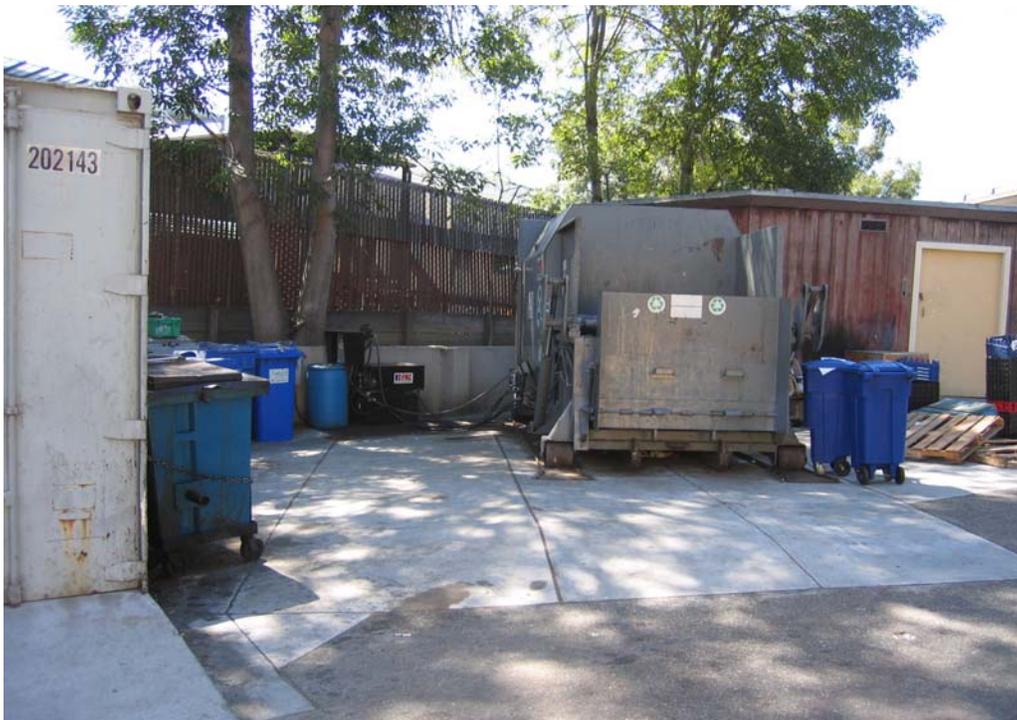
**Photograph 13:** *View of recycling dumpster. Note paint shed in the background and petroleum storage van in left foreground.*

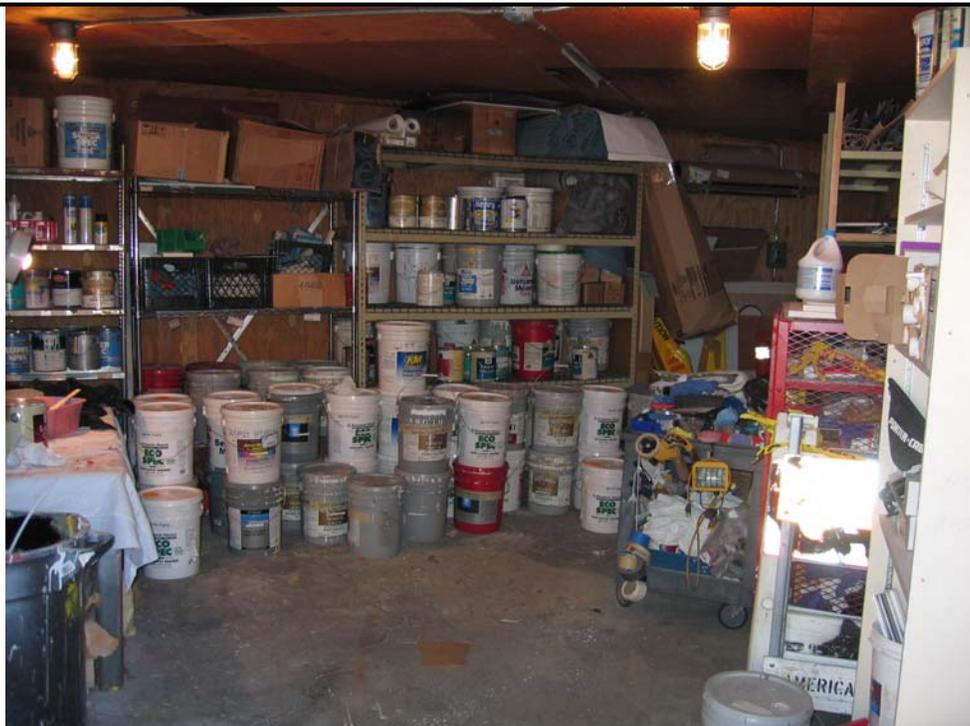
**Photograph 14:** *View of paints located in the paint shed.*

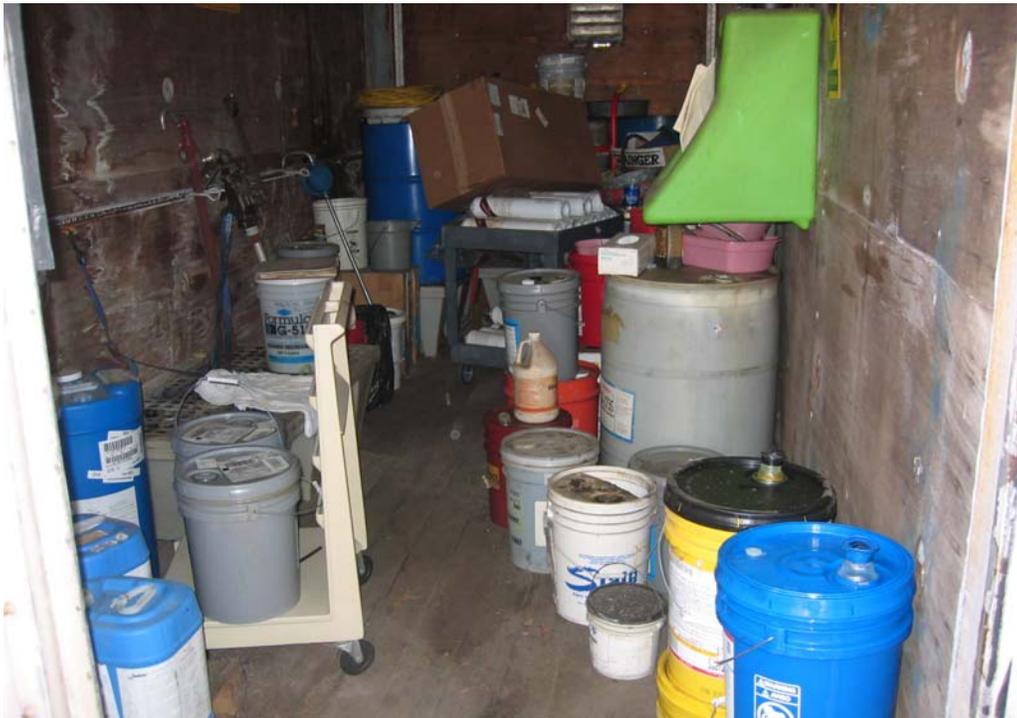
area, various storage vans and a paint shed were observed. According to Mr. Carlson, the storage vans are used for storing small quantities of hydraulic fluid and oil for the onsite generators. No staining was observed.

**Photograph 15:** View of the hydraulic oil containers located in the storage van depicted in photograph 13.

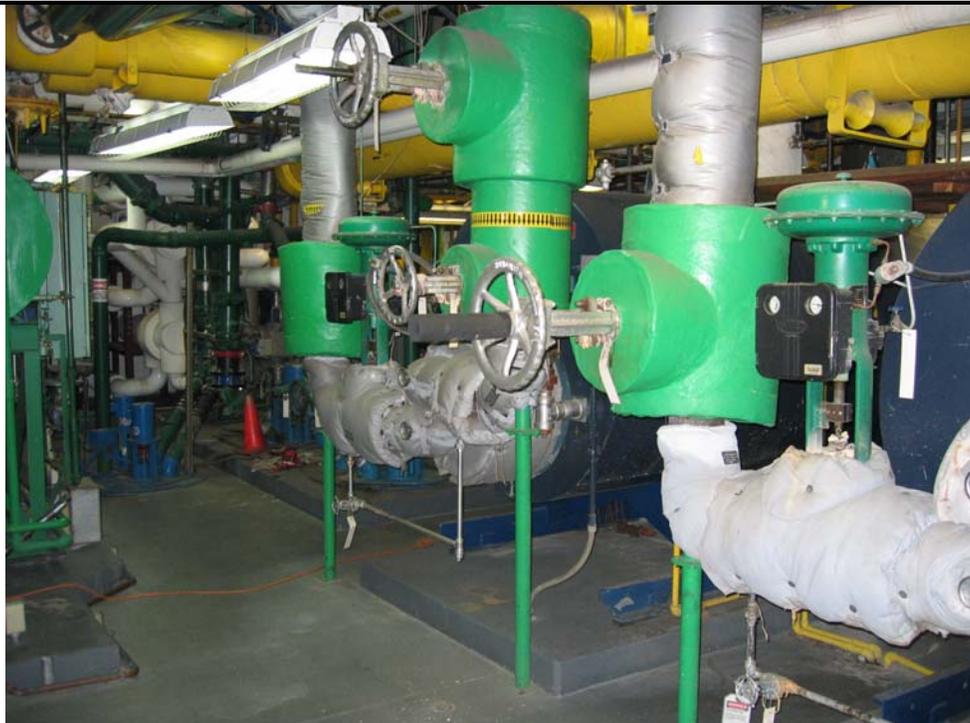
**Photograph 16:** View of the boilers located in the steam plant.

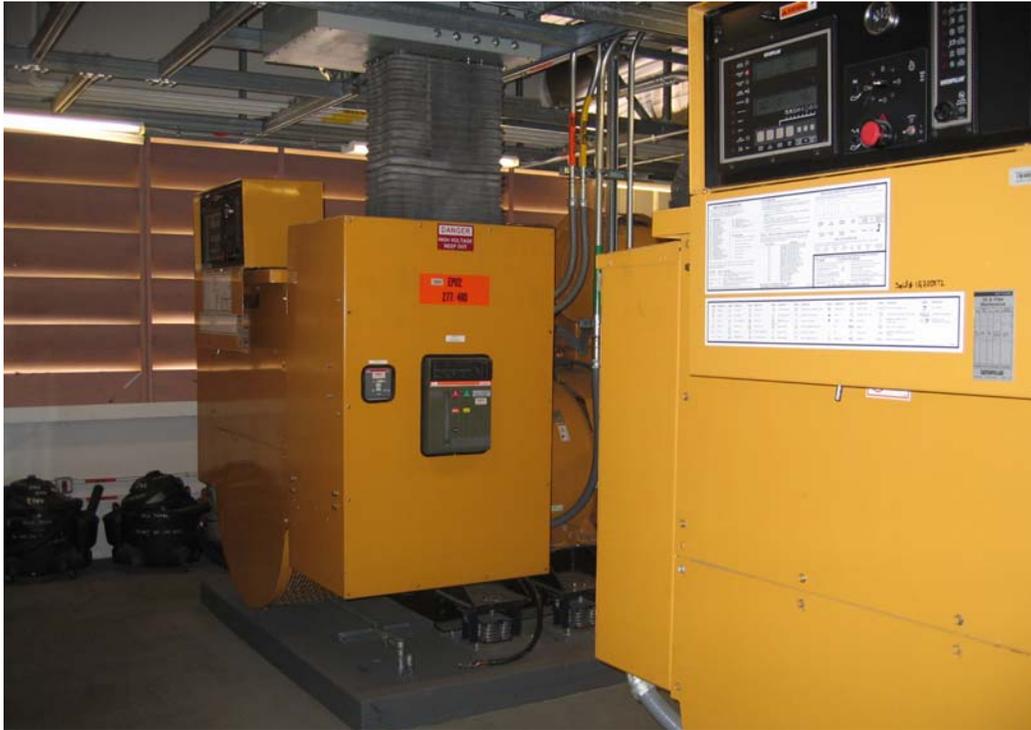
**Photograph 17:** View of the back-up generators located in the steam plant.

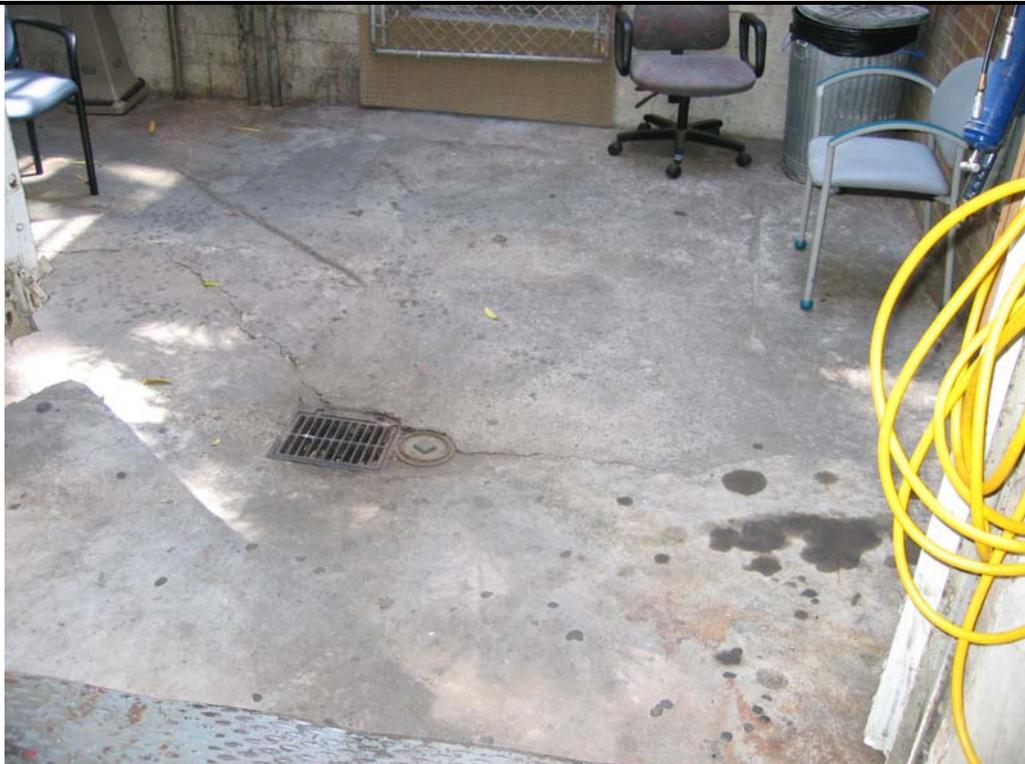
Based on interviews with CHRCO engineers we understand that an underground storage tank (UST) was previously located and removed near the southwest corner of wing B. No further information regarding the contents of the UST or whether any contamination was present upon removal was available.

Owners and operators of certain USTs are required to register those USTs with the state agency responsible for administrating the federally mandated UST program. SGI visually observed the Subject Property for surficial evidence of current USTs and ASTs. One 8,000-gallon diesel UST was present in the vicinity of the loading dock/dumpster area just outside the southwest portion of the main hospital building. According to Mr. Carlson, diesel fuel is used to power the backup generators. In addition, Mr. Carlson indicated that sometime in the past, a UST was located south of the engineering building at the corner of B and C sections of the AB&C building (Figure 3). The contents of the UST are unknown and to the best of his knowledge, the UST has been removed. No further information regarding the UST was available.

**Photograph 18:** View of the location of the former UST.

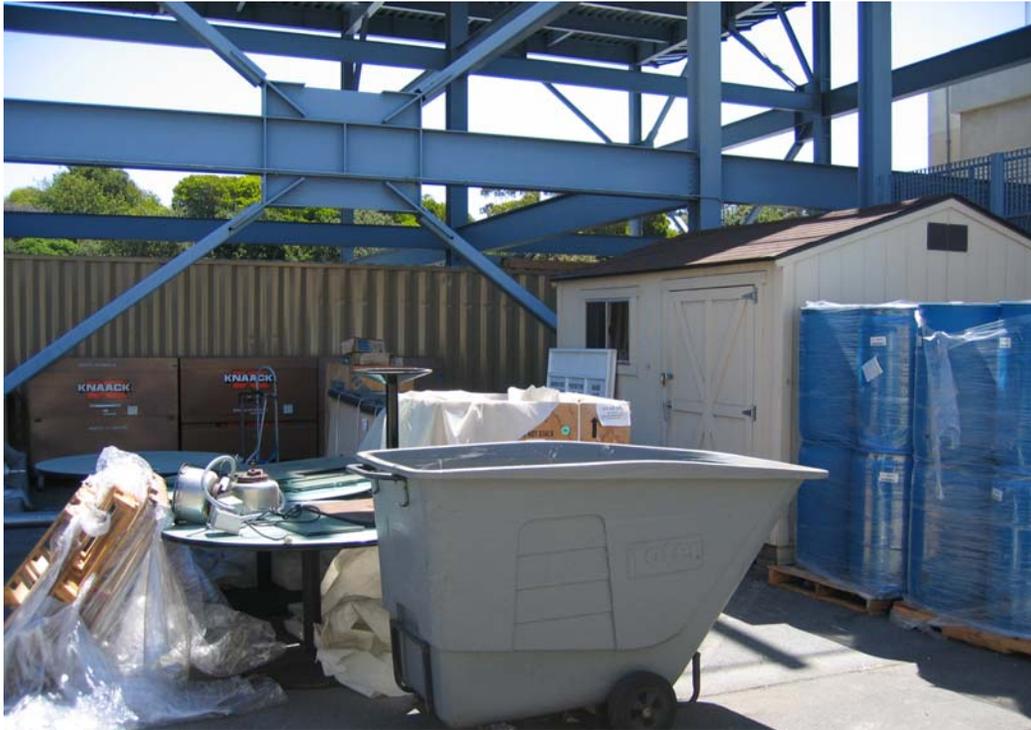
During the site reconnaissance, the outpatient care center, parking garage, office buildings, and helipad were observed from the exterior. Numerous storage sheds were observed beneath the helipad that according to Mr. Carlson, are used for storing construction materials related to ongoing construction activities at the hospital. Items stored included metal debris, small quantities of paint, pipe-fittings, and scrap wood. In addition, two 55-gallon drums were observed on the Subject Property beneath the helipad in the construction materials storage area. The contents of the drums are unknown but both drums were labeled as hazardous. No stains or spills were observed. The Subject Property was observed to be entirely paved with the exception of landscaped portions associated with the hospital.

**Photograph 19:** View construction supplies stored beneath the helipad.

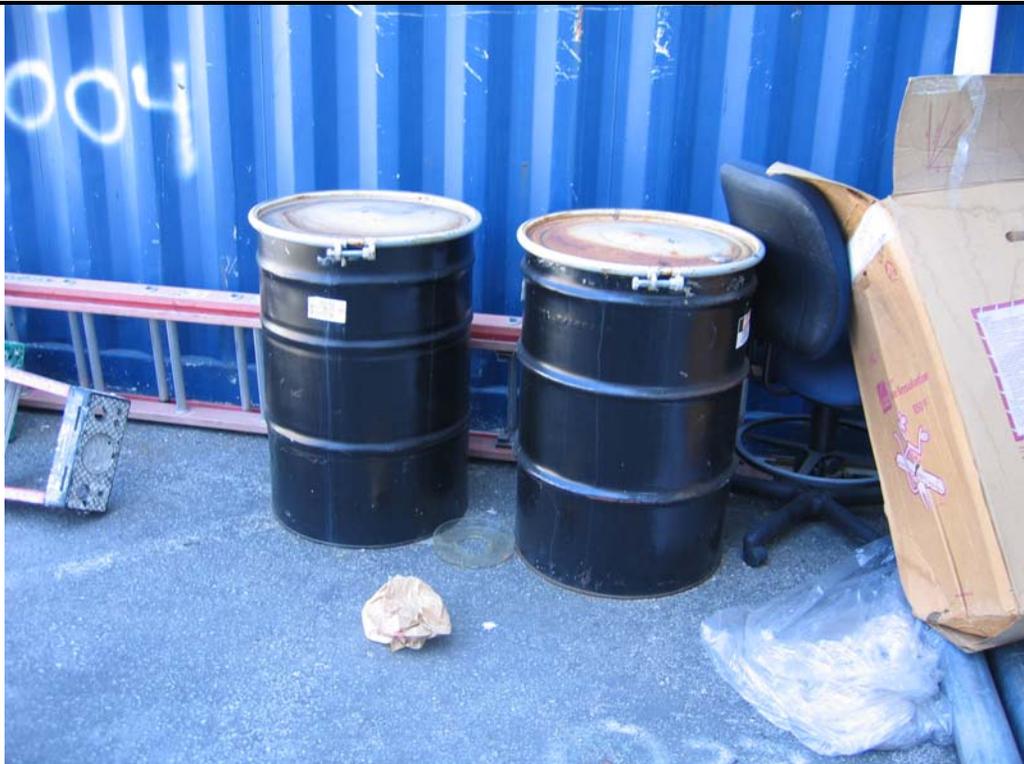
**Photograph 20:** View of the two 55-gallons drums labeled as hazardous located in the construction materials storage area.

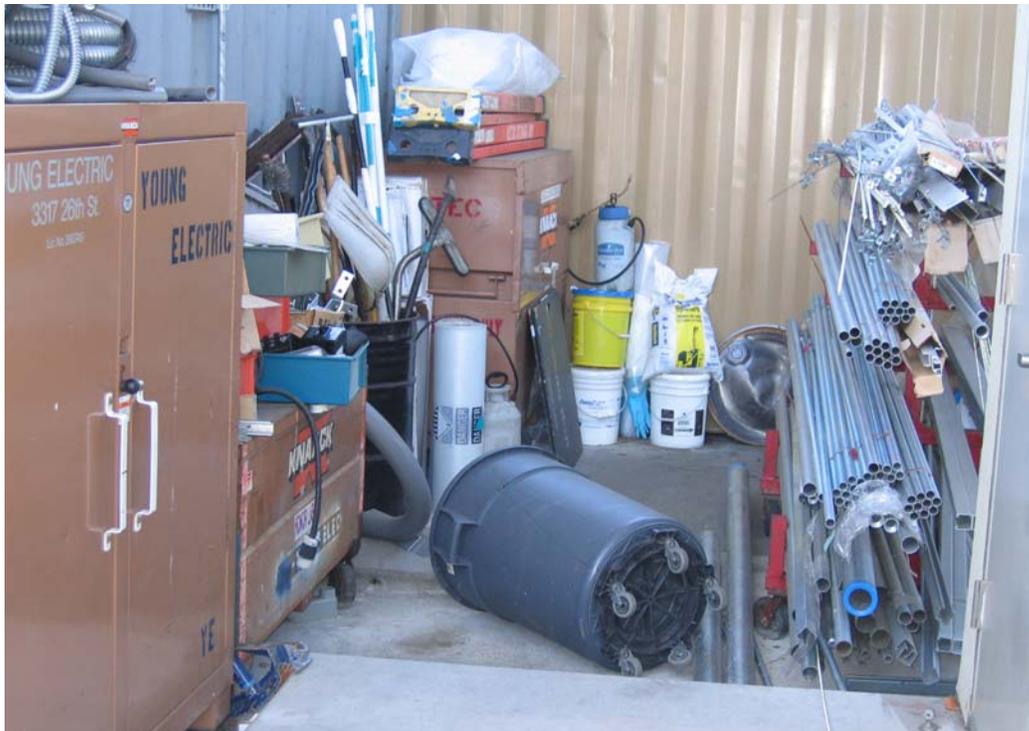
**Photograph 21:** View of pipe-fittings and construction materials stored beneath the helipad.

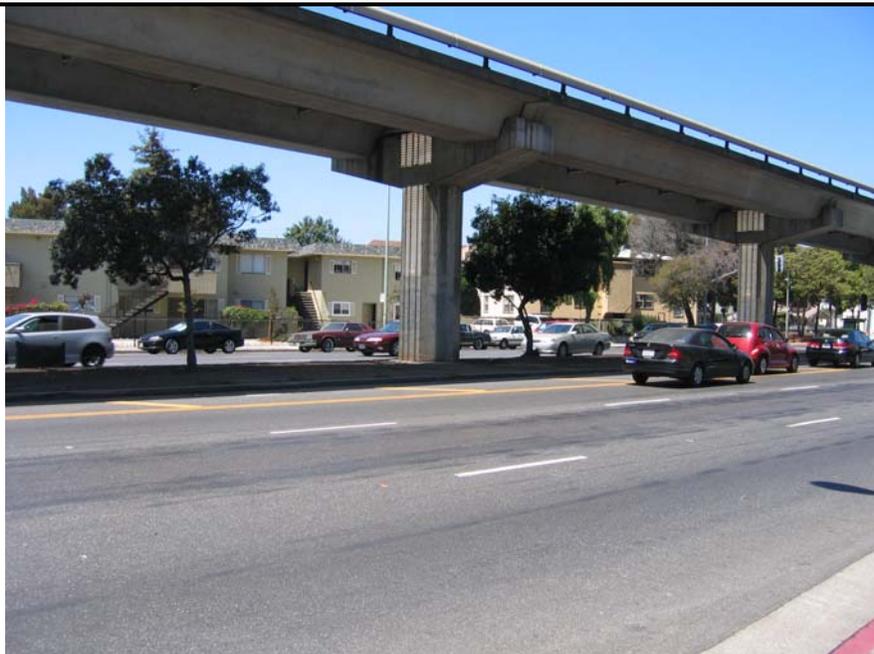
**Photograph 22:** View looking northwest from the southern portion of the Subject Property. Note BART transit line overhead and multi-level residential structures located in the background.

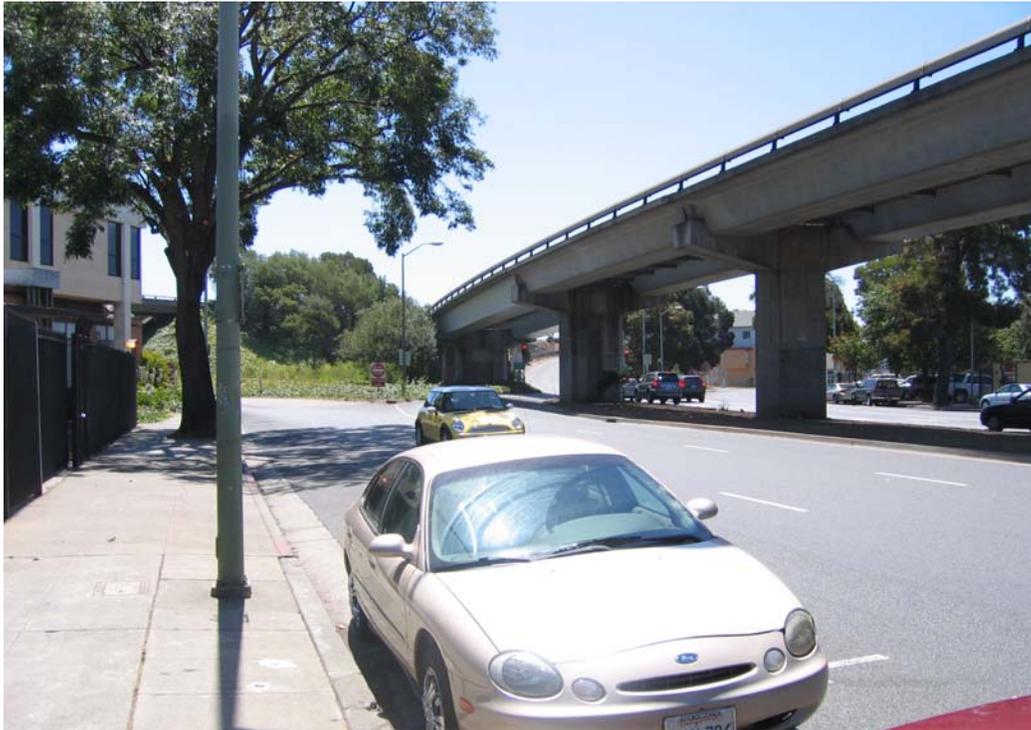
**Photograph 23:** *View looking south from the western perimeter of the Subject Property. Note off-ramp to Highway 24.*

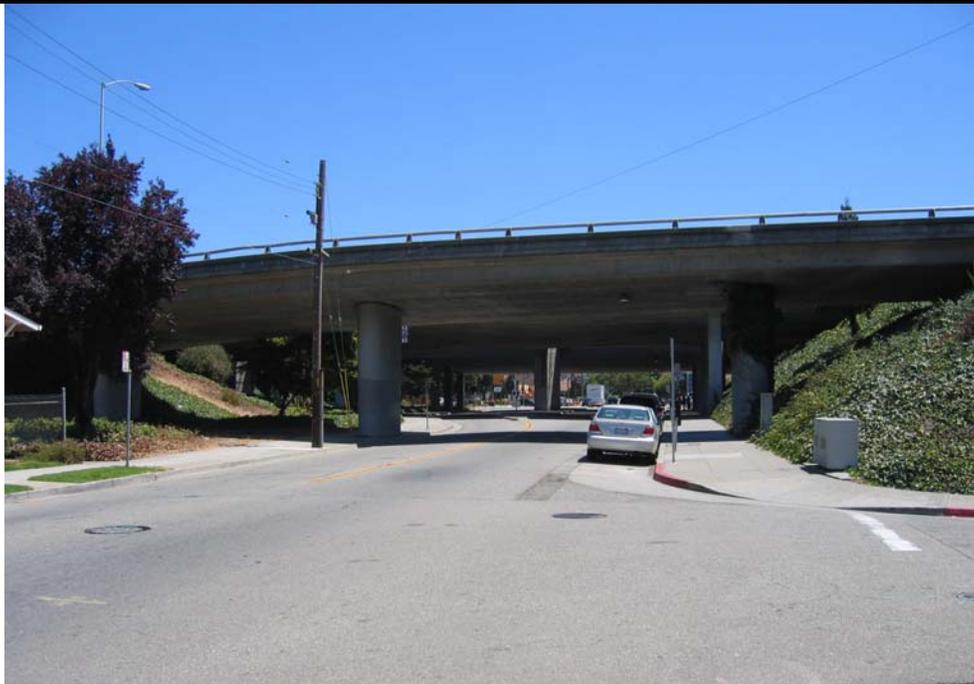
**Photograph 26:** *View looking east from the corner of 52<sup>nd</sup> and Dover Streets. Note Highway 24 overpass in foreground.*

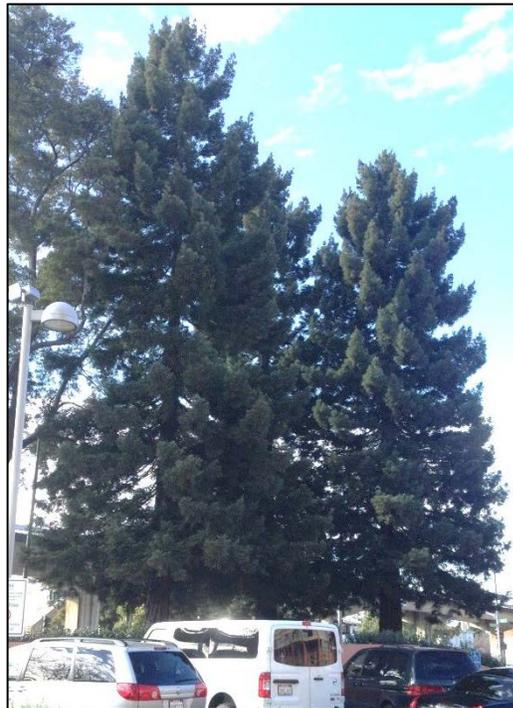
**Photo 1:** Coast redwoods #97-99 (l-r), growing near the corner of MLK Way and 52<sup>nd</sup> St., are in good condition.

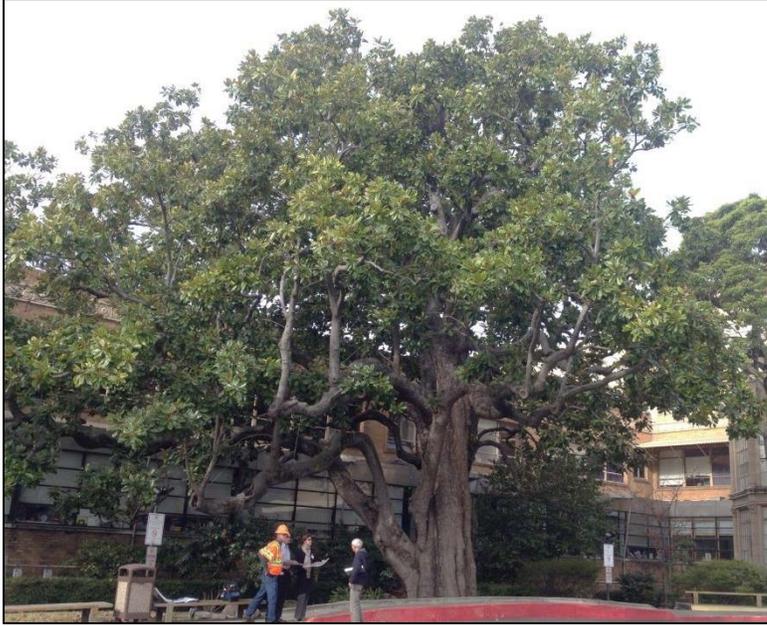
**Photo 2:** Southern magnolia #82, located in the Hospital's interior courtyard, is the largest tree evaluated and is in good condition.

Southern magnolia #82 is the largest tree evaluated. It is mature in development, with a trunk diameter of 78 inches. Many large lateral limbs have been cabled. I noted six cables throughout the canopy, the majority of which support limbs on the south half of the canopy. The tree is in good condition despite its size and age. The canopy is dense with dark green leaves, and shoot growth appears normal. A portion of the canopy extends over the building that is located approximately 25 feet west of the base of the tree. This tree is unique in its size and age, and in its condition given these two factors.

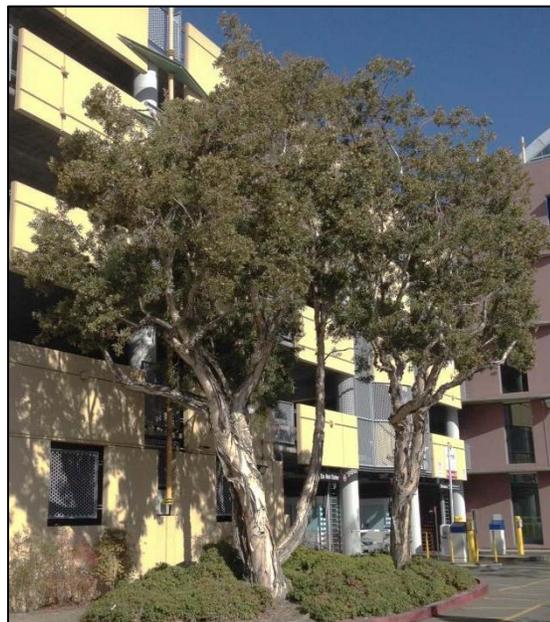
**Photo 3:** Flaxleaf paperbark #7 (r) and 9 (l) are in good condition with good form and structure.

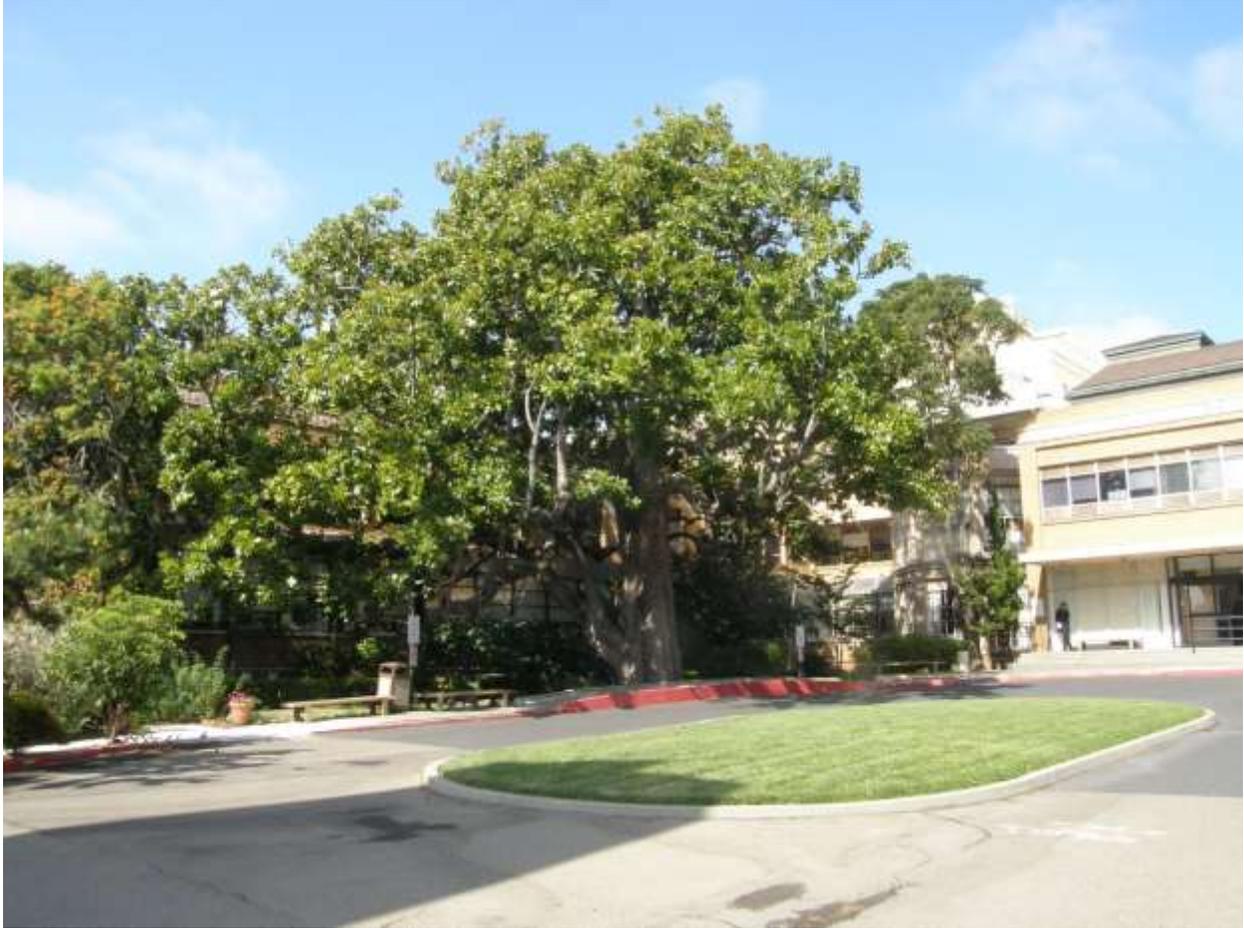
Figure 1. The Southern magnolia tree at the Oakland Children's Hospital. The tree was planted in 1860. The trunk measures 74 inches in diameter at approximately 16 inches above grade and just below the primary crotch of the tree. The tree is approximately 62 feet tall with a foliar spread of approximately 82 feet measured north-south. The foliar spread is approximately 72 feet measured west-east. The canopy of the tree is out of balance to the west and south.

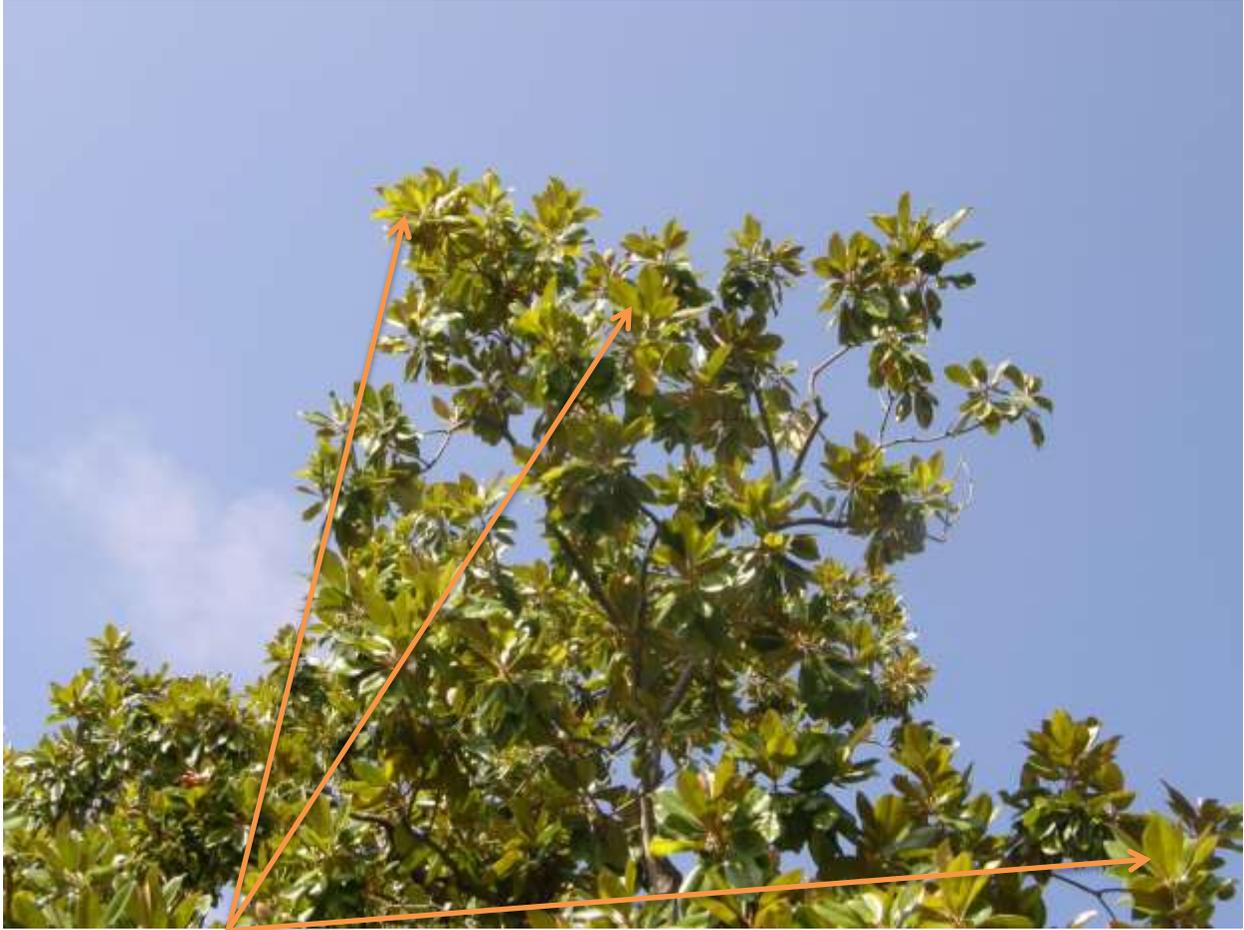
Figure 2. The foliage is remarkably lighter in color for what I would expect for this time of year. It is my opinion that the tree is in fair health.

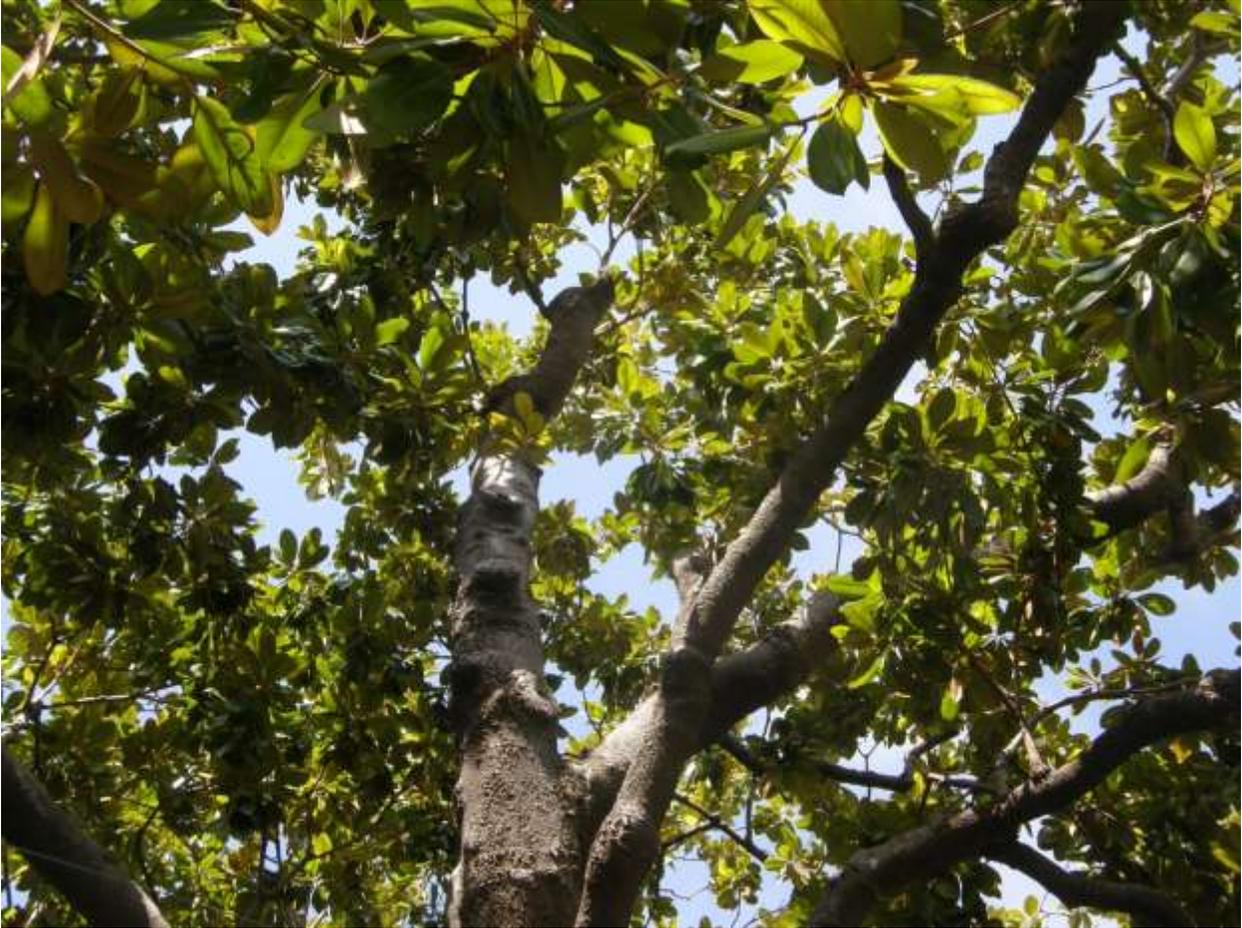
Figure 3. The tree was topped in the past and there are pruning wounds throughout the upper canopy that appear to be up to six inches in diameter.

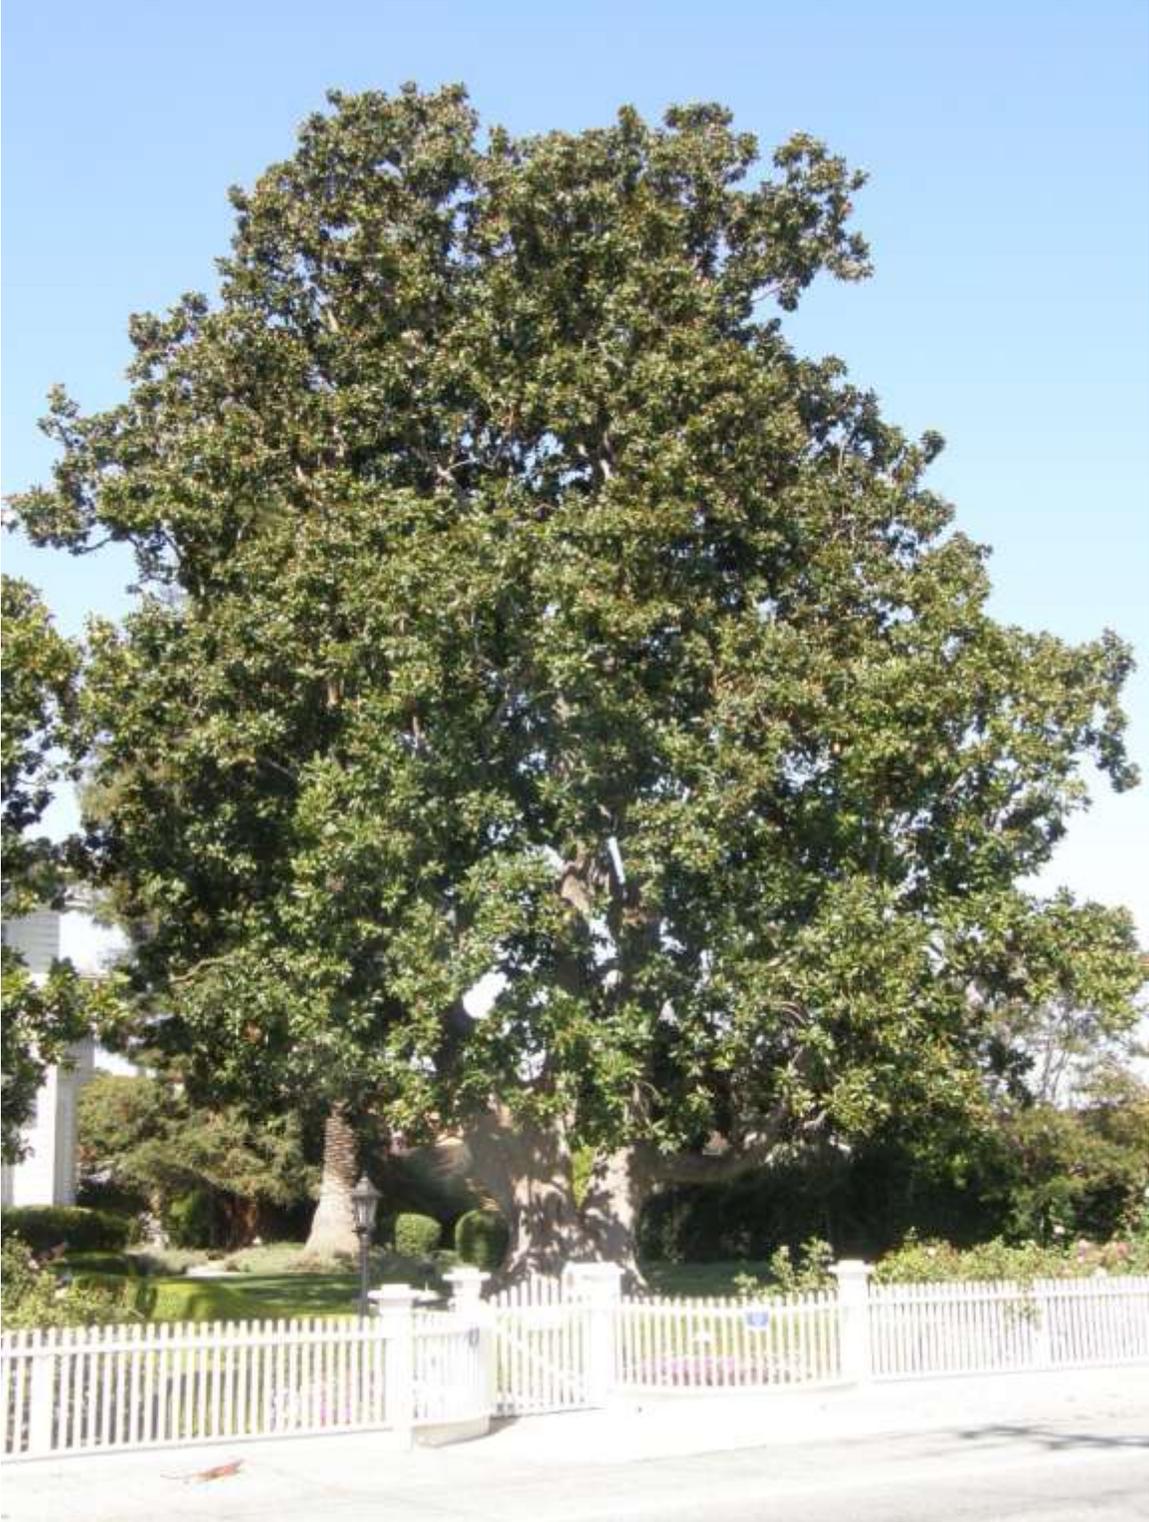
Figure 4. This Southern magnolia is located at the Farrington House in San Jose. The tree was planted circa 1920. Measurements were not taken but the tree has approximately the same size of trunk. It is narrower but much taller than the magnolia at the Children's Hospital. The tree is in very good health judging by the color, the size, and the amount of foliage. This tree was thinned last August.

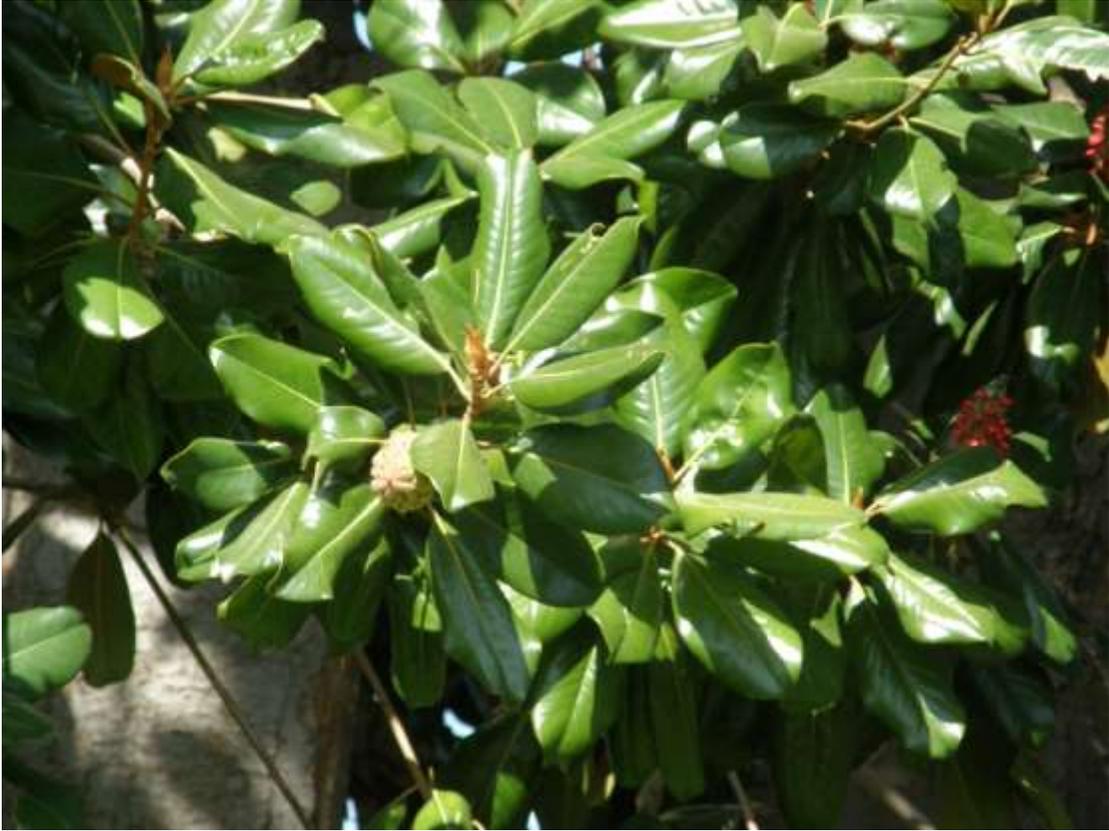
Figure 5. A close up of the foliage of the Farrington magnolia. The color is a deep and rich green.

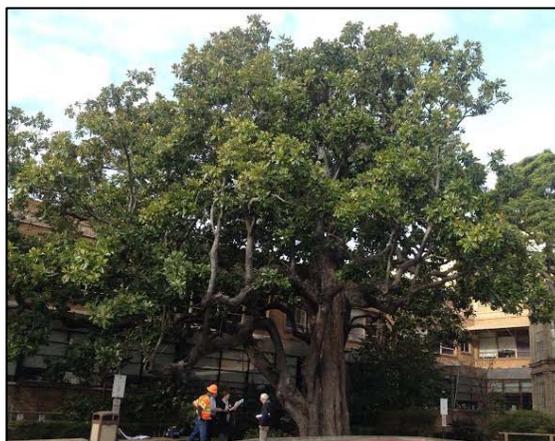
The trunk is 78 inches in diameter and appears typical for the species. The tree appears healthy with good vigor, spreading form, and fair structure (Photo 1). Multiple large-diameter limbs extend south and north, arising at approximately 8 feet. Several limb-supporting cables suggest the presence of structural weaknesses in the tree.

**Photo 1:** The large, over-mature southern magnolia (#82) is located in the hospital courtyard east of the B/C wing.

west. The lower canopy is dense with dark green leaves. The upper canopy is slightly thin, and leaves in this portion of the crown appear slightly yellowed or chlorotic. Shoot growth and new leaf growth appears normal throughout the crown.
