**1261 Harrison Street**  
**Category II Demolition Findings**  
October 2017

Appendix C

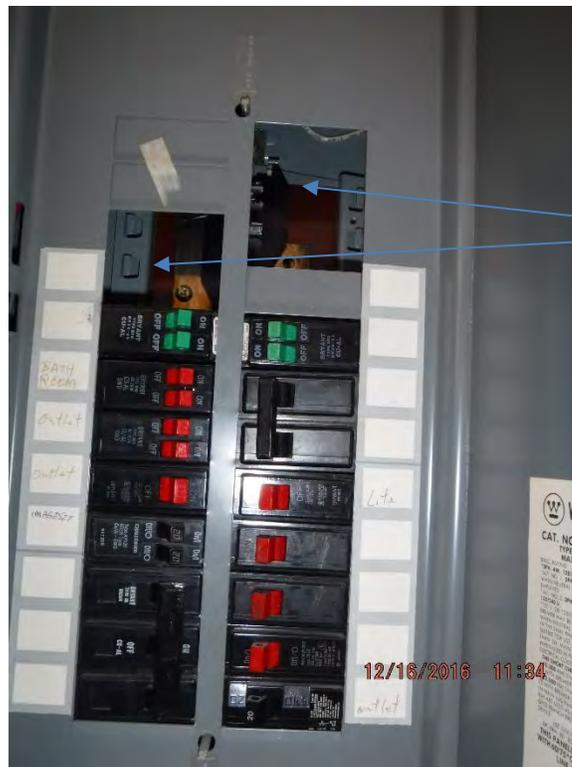
Unit 323 – Interior

Openings in  
Electrical Boxes –  
Knockouts Removed

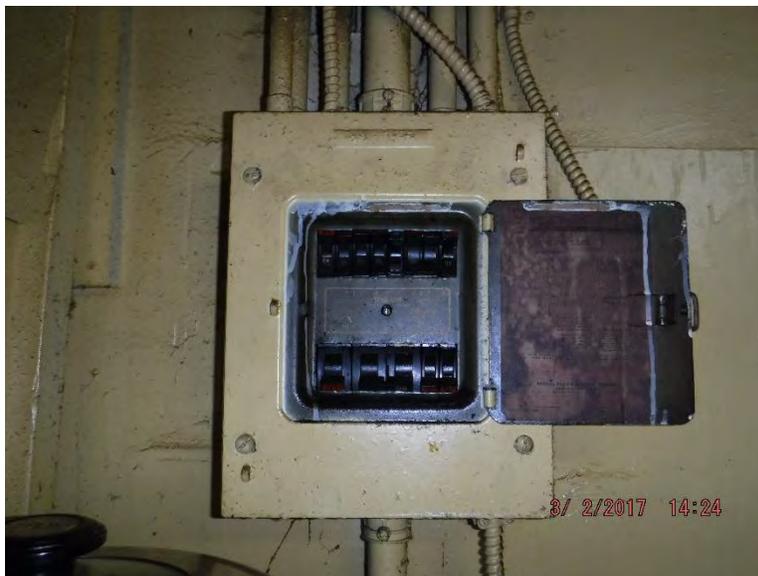
Unit 1261 Harrison – Interior – Federal Pacific Electrical Panel

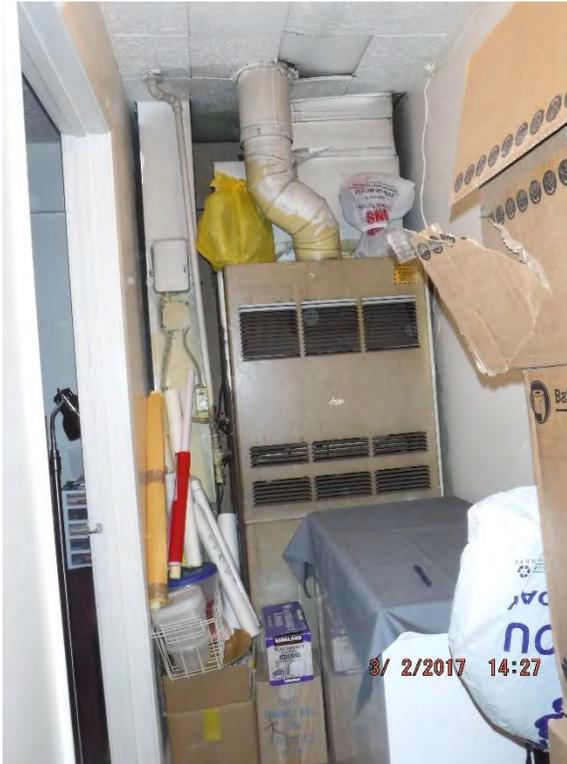
Unit 1261 Harrison – Interior - Furnace

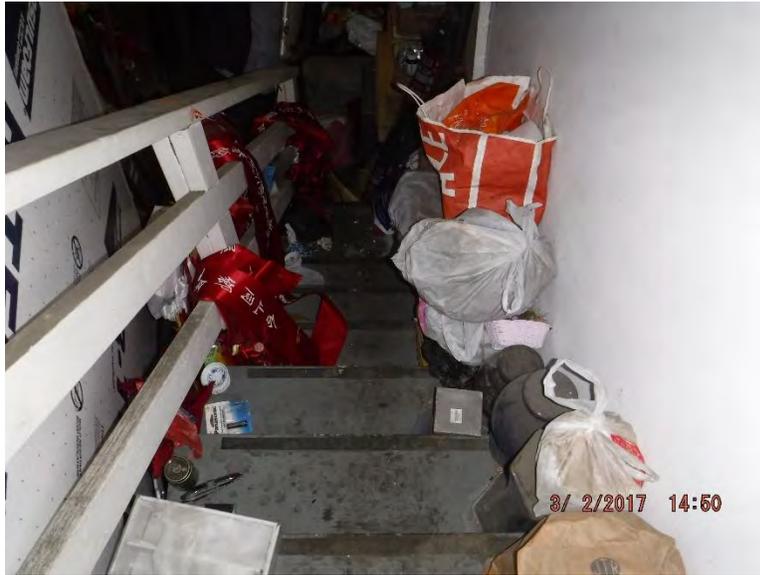
Unit 1269 – Interior Condition – Stairway Leading from Office

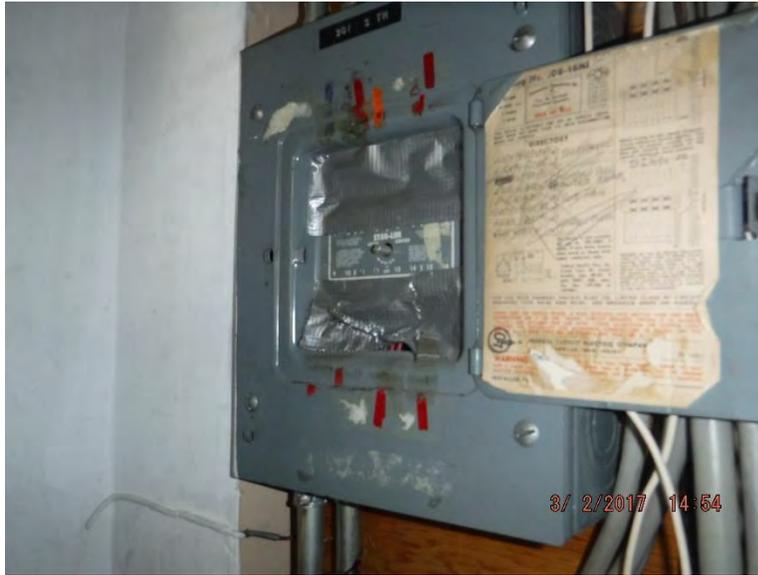
Unit 1269 – Closet in Front – Modified F.E. Panel

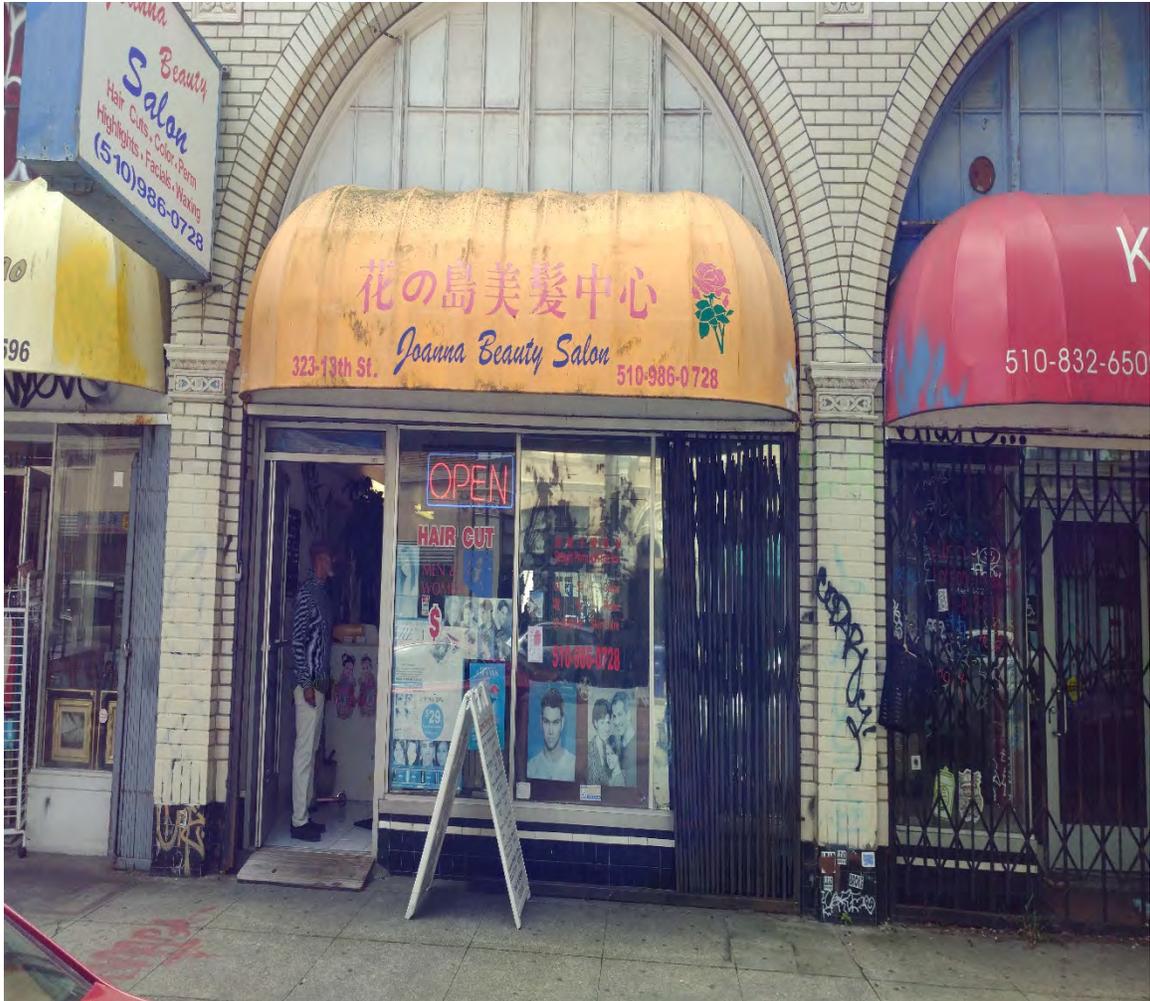
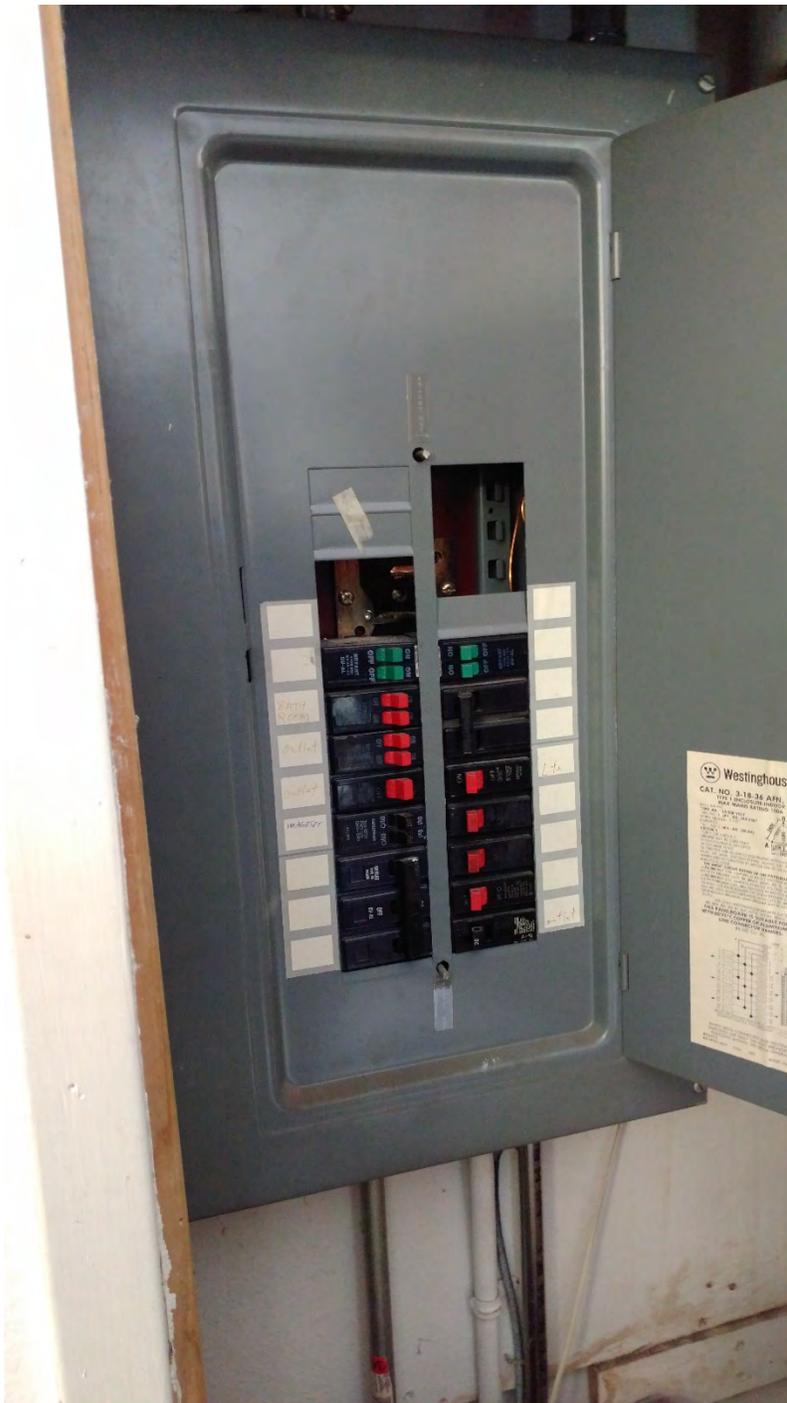
323 13<sup>th</sup> St

On April 13, 2017 we met with the property representative to take photos of the interior of this unit. It was reported to our inspection team that the tenant had vacated the unit. Upon inspection, we found the unit had been cleared of all furnishings; the sleeping room, storage and fire extinguisher hazards were abated as a result of the vacation. The previous electrical and wall penetration hazards and faulty exit signs noted in our first inspection remain. Additional electrical hazards were created due to the removal of the light fixtures, in the main lobby and hallway, resulting in open junction boxes and exposed wires.

Vacant buildings are to be secured, safe guarded and fire protection equipment maintained and all combustible materials removed from the premises, Where Hazardous materials are involved, the owner must comply with the requirements set forth in Chapter 50, Section 5001.6 of the Fire Code. (CFC 311)

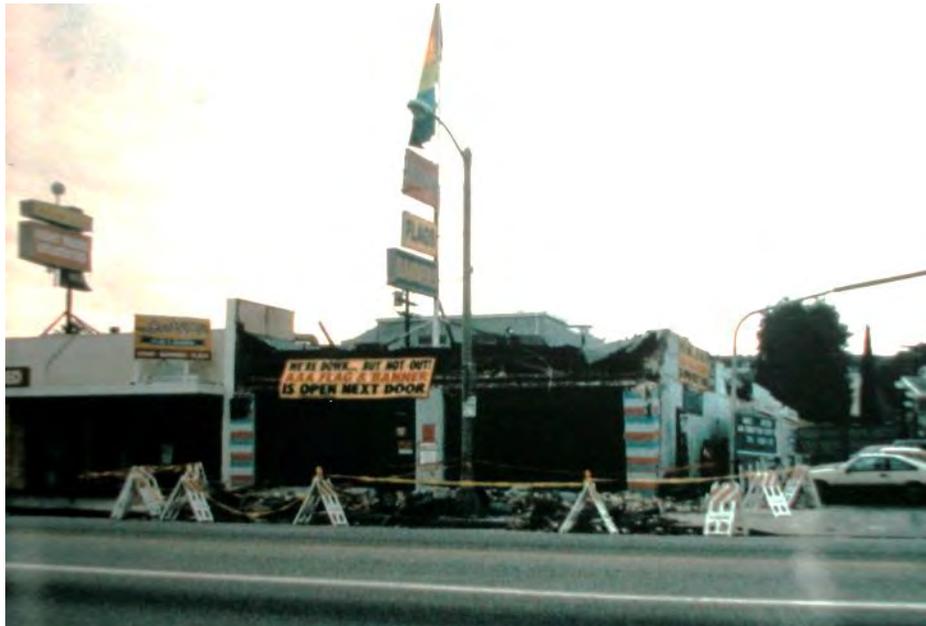
**Figure 2: Parapet collapse, Panorama City, California, 1994 Northridge earthquake**

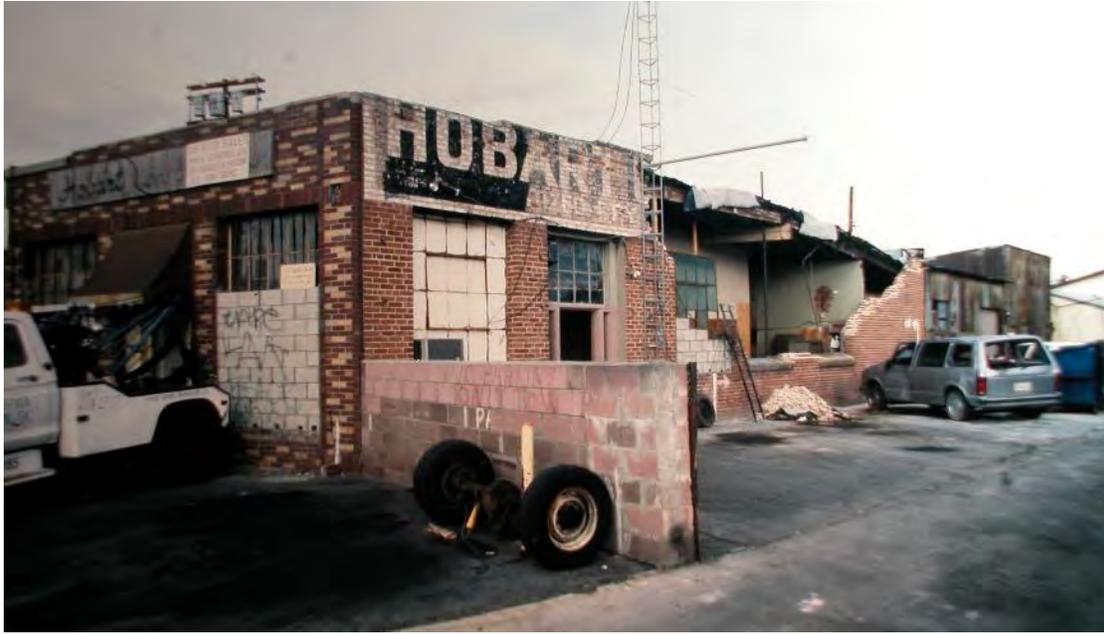
**Figure 3: Collapse of single story commercial building, 1994 Northridge earthquake**

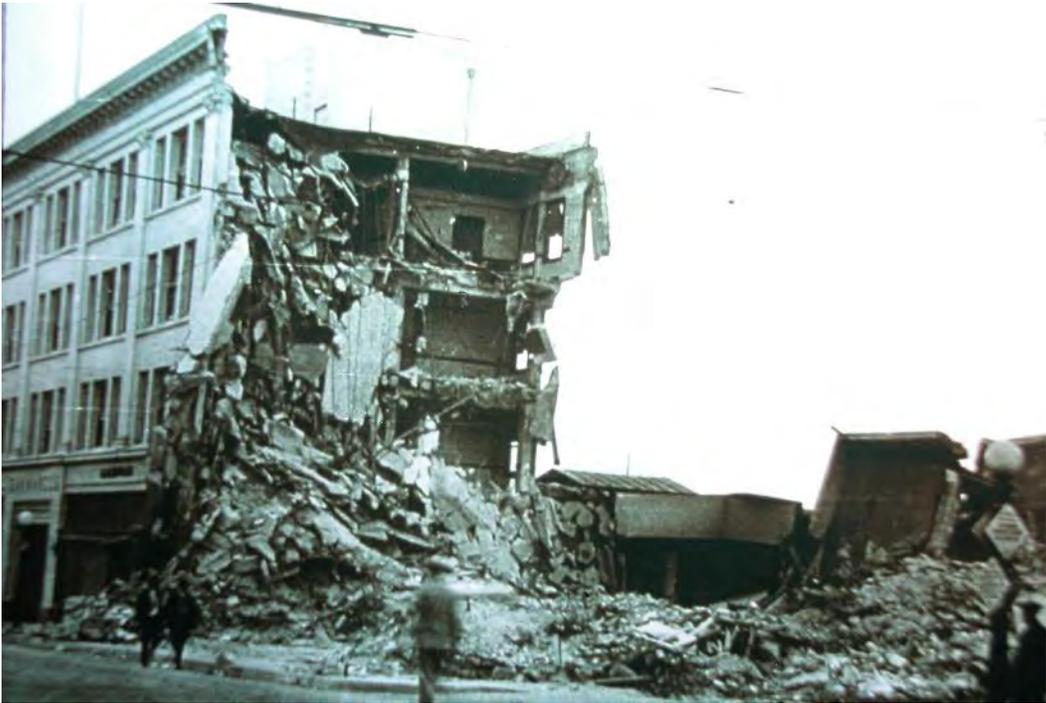
brick masonry wall panels “blow-out” from the building because they have inadequate strength. Figure 4 shows such a failure in a building in Culver City, California. If the walls have adequate strength to resist out-of-plane forces, and are adequately anchored to the structures, they may fail in shear due to in-plane forces, which can in turn result in collapse of the wall. Figure 5 shows such failures in a building in Santa Cruz, California, following the 1989 Loma Prieta earthquake. In other cases, the floors and roofs that tie the building together have inadequate strength and stiffness, allowing total collapse to occur. Figure 6 shows such a failure that occurred in the 1933 Long Beach, CA earthquake.

**Figure 6: Massive collapse of building in Long Beach, CA 1933**

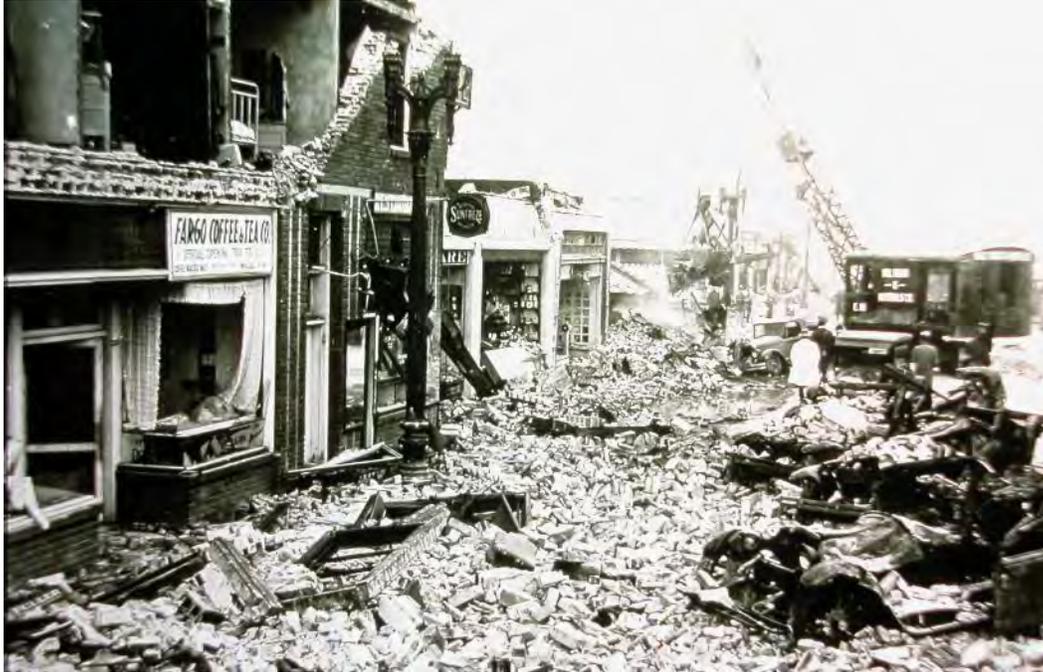
**Figure 7: Street scene in Long Beach California following 1933 earthquake**

Following the 1933 Long Beach earthquake, and the failure of many unreinforced masonry schools, apartments and commercial buildings (Figure 7), California enacted legislation prohibiting further construction of unreinforced masonry bearing wall buildings. However, thousands of these structures that predate the ordinance remain, posing a real threat to Californians.

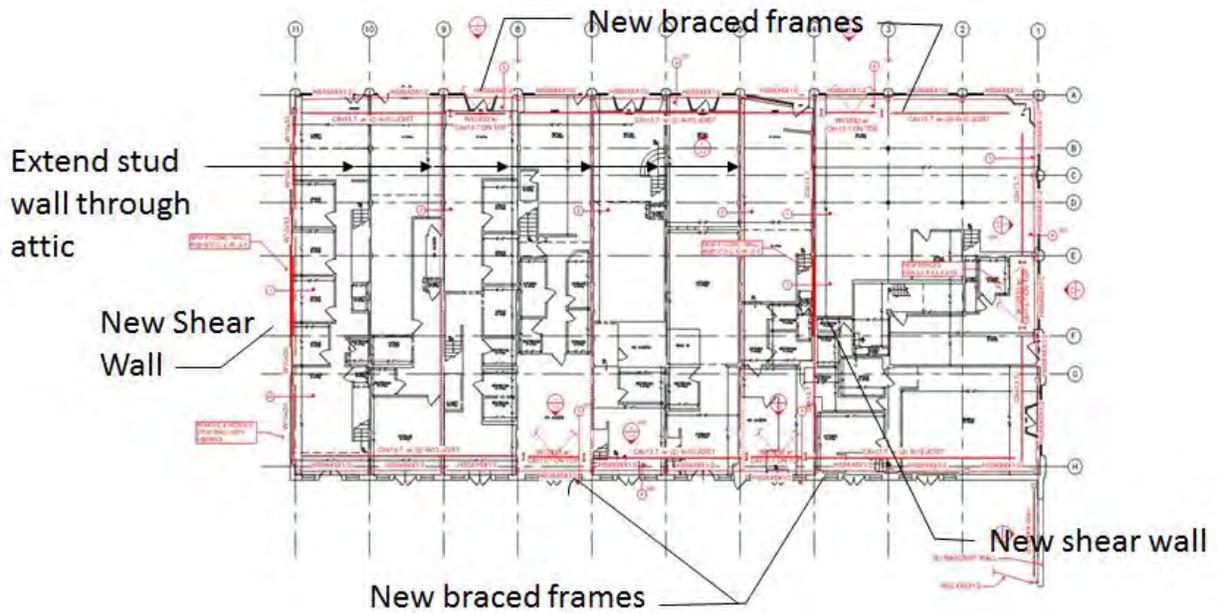
**Figure 16: Roof Level Retrofit Structural Members**

The existing straight-sheathed roof diaphragm has inadequate strength for the computed seismic demands. The lack of full height cross walls and the large spans are the primary reason for the high diaphragm stresses.

We recommend installing plywood sheathing over the existing straight board sheathing. In addition, we recommend providing plywood sheathing to the bare wood stud walls above the

cross walls at gridlines 5, 7, and 9. This will connect these cross walls to the roof diaphragm and reduce the shear demand on the new diaphragm (Figure 16).

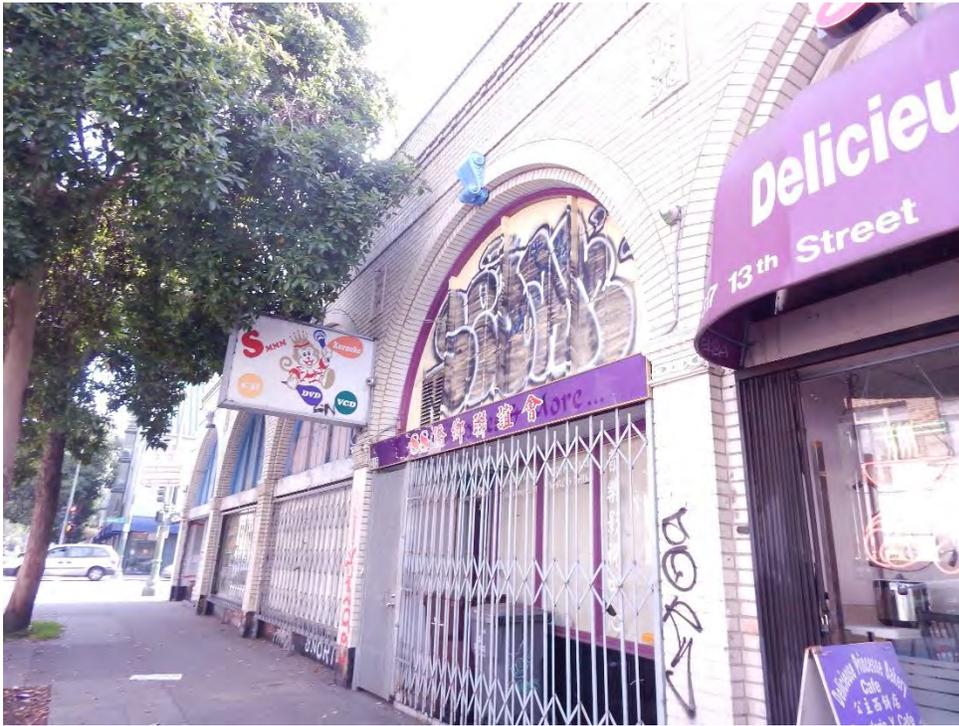
**Photo 1**

We observed that the one story rectangular building has approximate plan dimensions of 180 ft east-west by 84 ft north-south. The eastern two-thirds of the plan is divided into narrow shops, each approximately 17.5 ft wide by 84 ft long with entrances along the northern face (Photo 1). There is a larger store at the northeast corner called Smiling South (USA) Inc. whose plan is approximately 50 ft by 50 ft. The two shops (temple and flower shop) at the southeast corner are oriented in the east-west direction (Photo 2).

Entrances along the northern face.

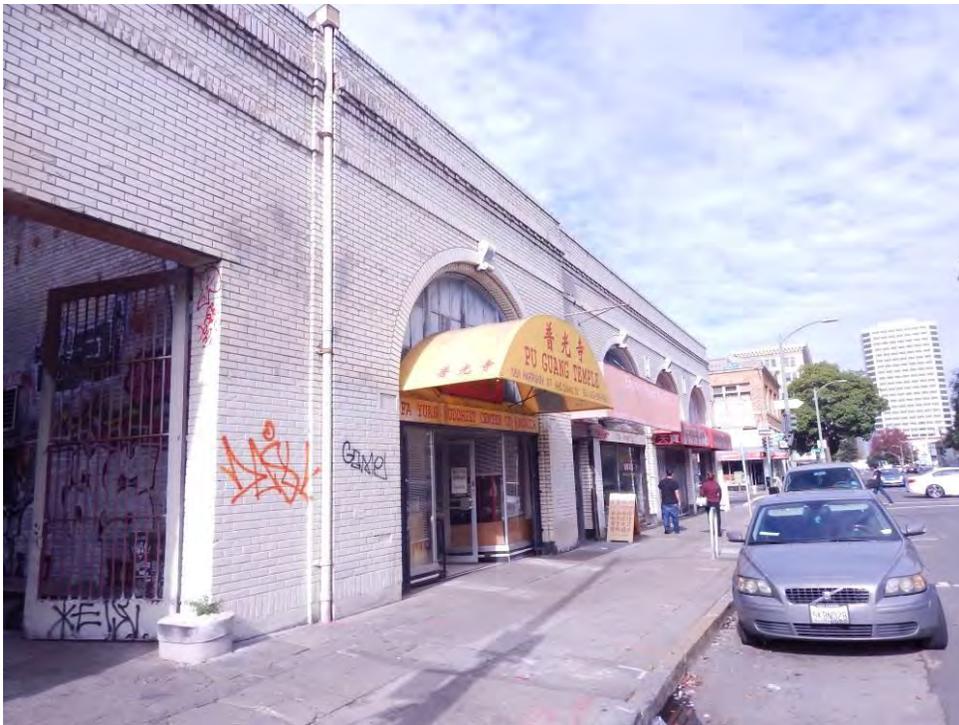
**Photo 2**

The two shops (temple and flower shop) at the southeast corner are oriented in the east-west direction.

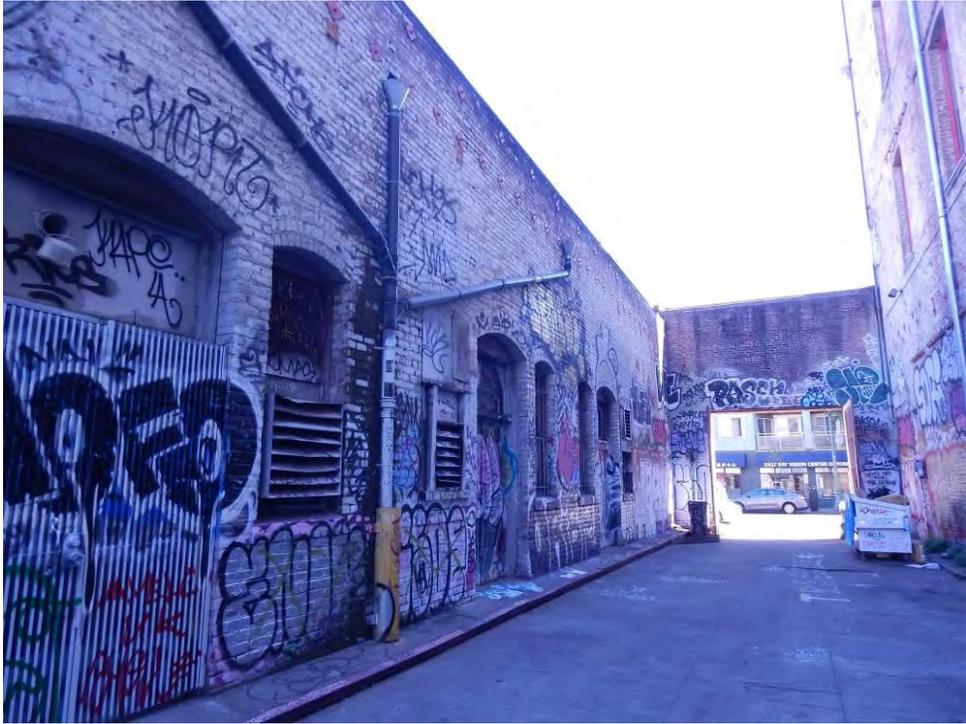
**Photo 3**

The south wall is unreinforced masonry brick and is exposed along an alley (Photos 3 and 4) that separates the building from its neighbor to the south. We confirmed this wall is 3 wythes and approximately 13 in. thick. The north and east walls, fronting 13<sup>th</sup> and Harrison Street respectively, are also brick masonry in the configuration of a series of arches, creating door and window space, topped by deep brick spandrel elements. The brick piers between adjacent arches are approximately 27 in. wide and are spaced at approximately 18 ft on center. The west wall, also of unreinforced brick masonry construction, appears to be a shared wall with the neighboring building (Photo 5) to the west.

The south wall is unreinforced masonry brick and is exposed along an alley.

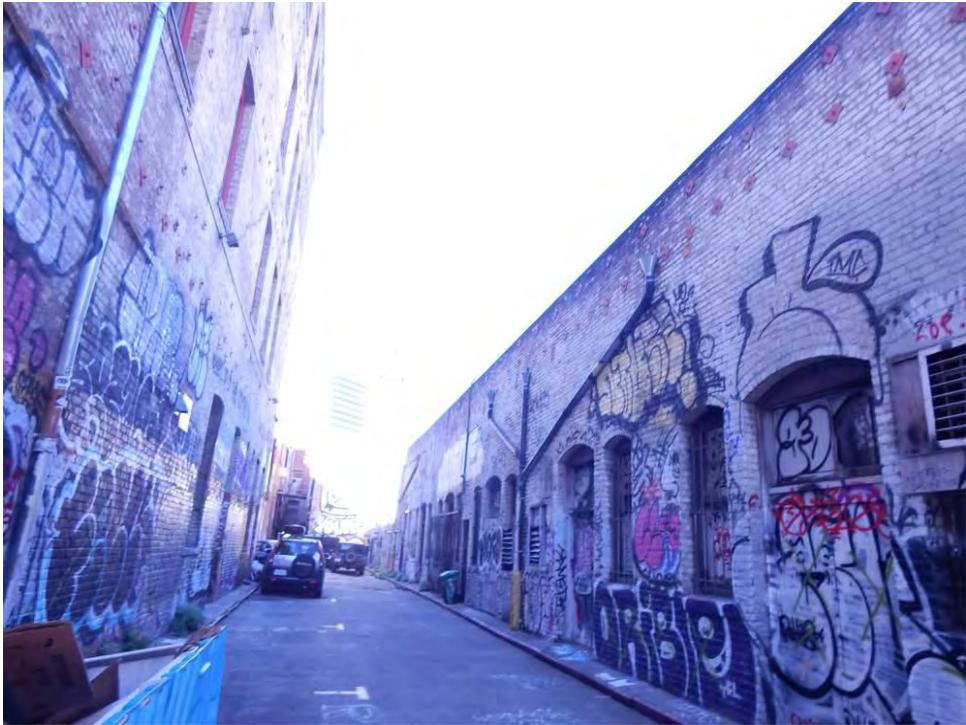
**Photo 4**

The south wall is unreinforced masonry brick and is exposed along an alley.

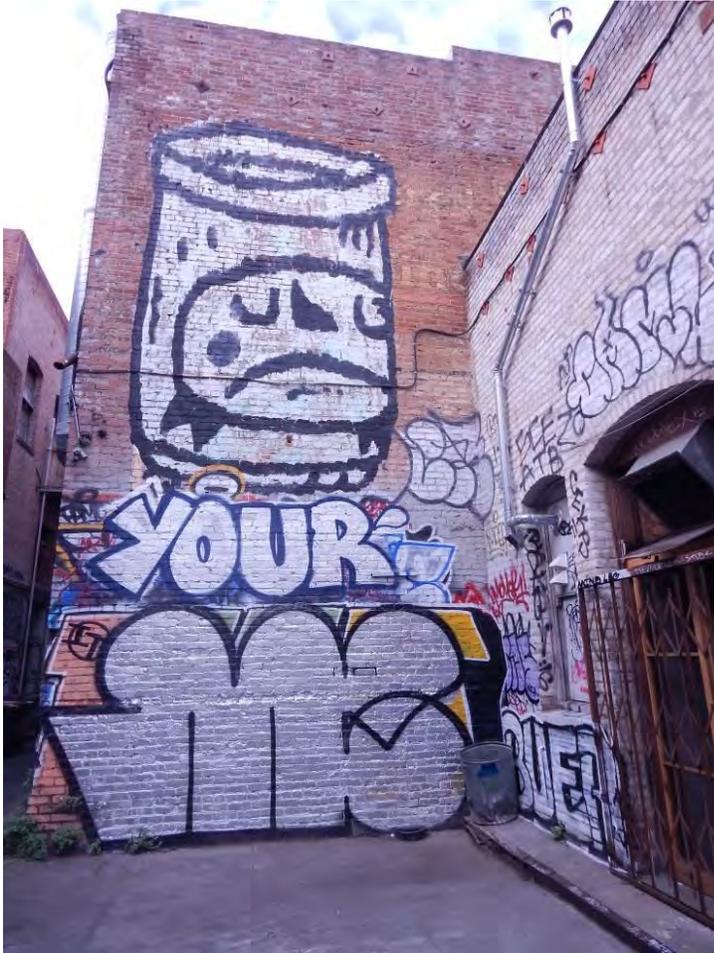
**Photo 5**

The west wall, also of unreinforced brick masonry construction, appears to be a shared wall with the neighboring building to the west.

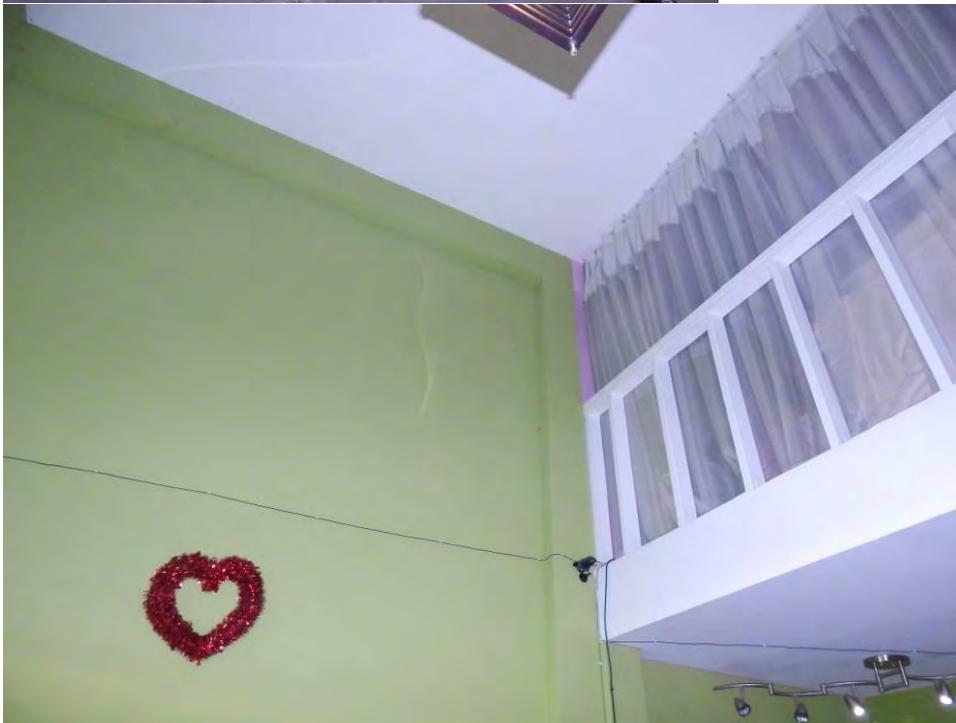
**Photo 6**

The dividing walls between shops are comprised of wood framing with plaster finish on wood lath (both sides). There are 8x8 wood posts at approximately 18 ft on center integrated into the dividing walls. These columns support large wood beams, which also appear to be 8x8, that frame in the north-south direction just below the ceiling (Photo 6). We did not observe any interior masonry brick walls.

Columns support large wood beams, which also appear to be 8x8, that frame in the north-south direction just below the ceiling.

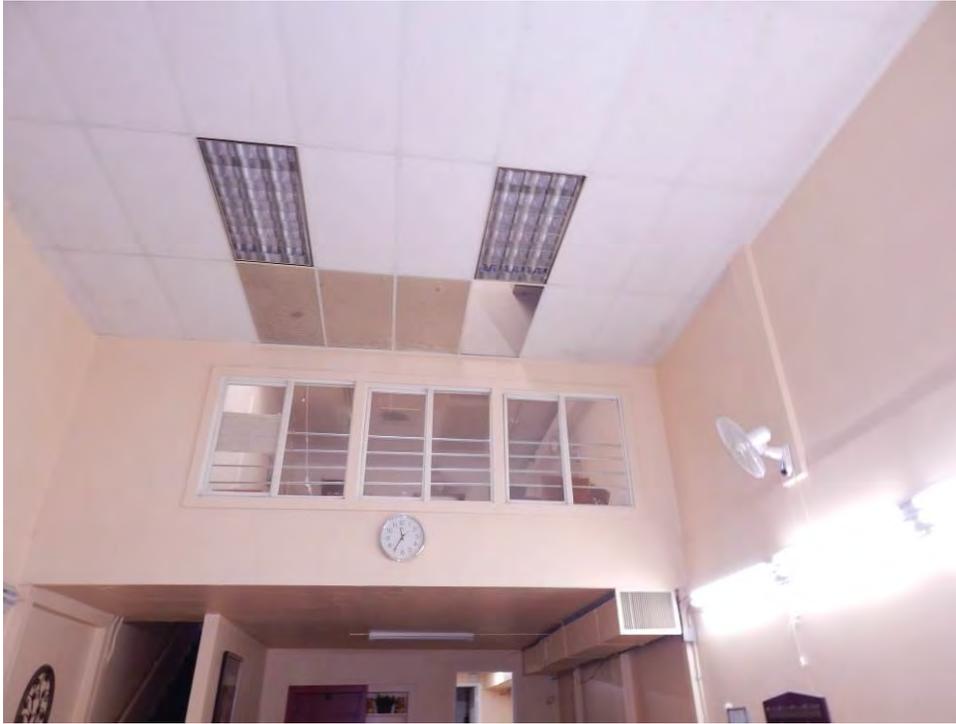
**Photo 9**

The mezzanine floors are supported on interior wood stud walls and frame into the main dividing partition walls and columns (Photo 9).

The mezzanine floors are supported on interior wood stud walls and frame into the main dividing partition walls and columns.

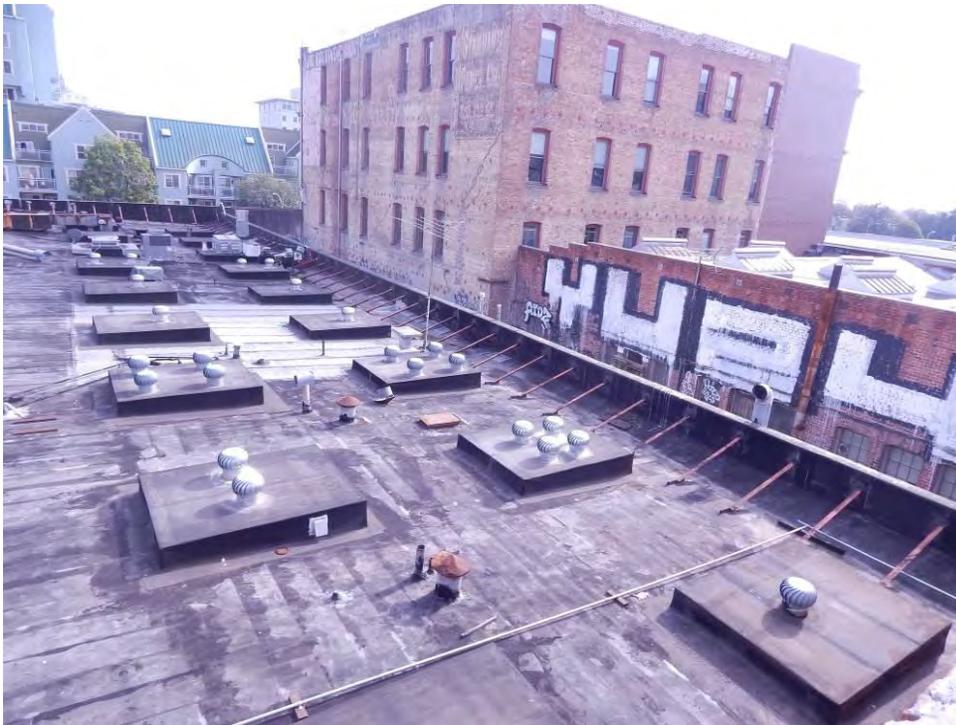
**Photo 10**

We observed roof parapet bracing on the south and east elevations at approximate 4 ft on center (Photo 10). There are no parapet braces along the north side as this parapet is less than 12 in. tall. There is no parapet on the west wall as the roof runs into the adjacent building, which is one story taller than the Harrison building.

Roof parapet bracing on the south and east elevations at approximate 4 ft on center.

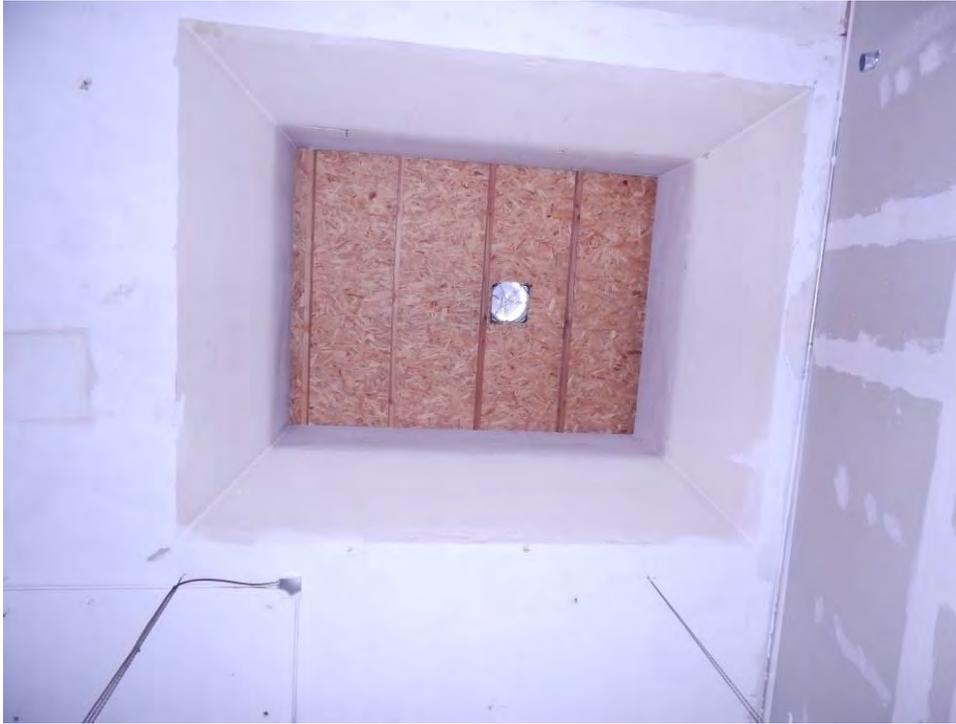
**Photo 11**

There are three skylights, located at even spaces along the north-south direction in each of the 17.5 ft wide bays. Most of these skylights are covered with sheathing (Photos 10 and 11).

There are three skylights, located at even spaces along the north-south direction in each of the 17.5 ft wide bays. Most of these skylights are covered with sheathing.

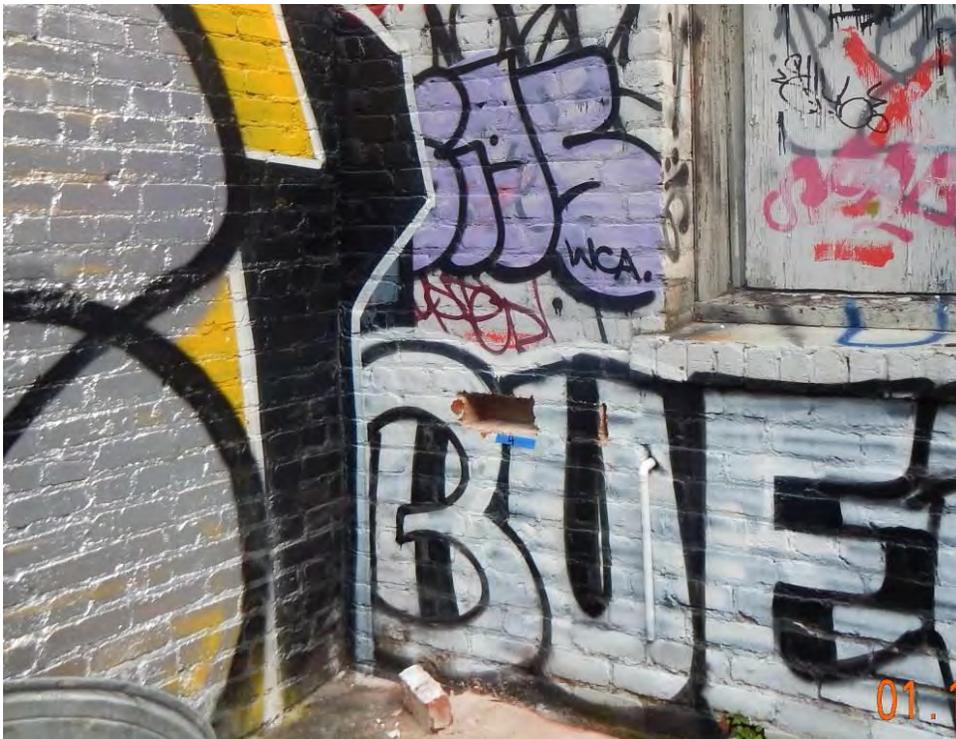
**Photo 12**

One of the tested locations performed by AME.
