Alameda Avenue Intersection / Gateway to Oakland

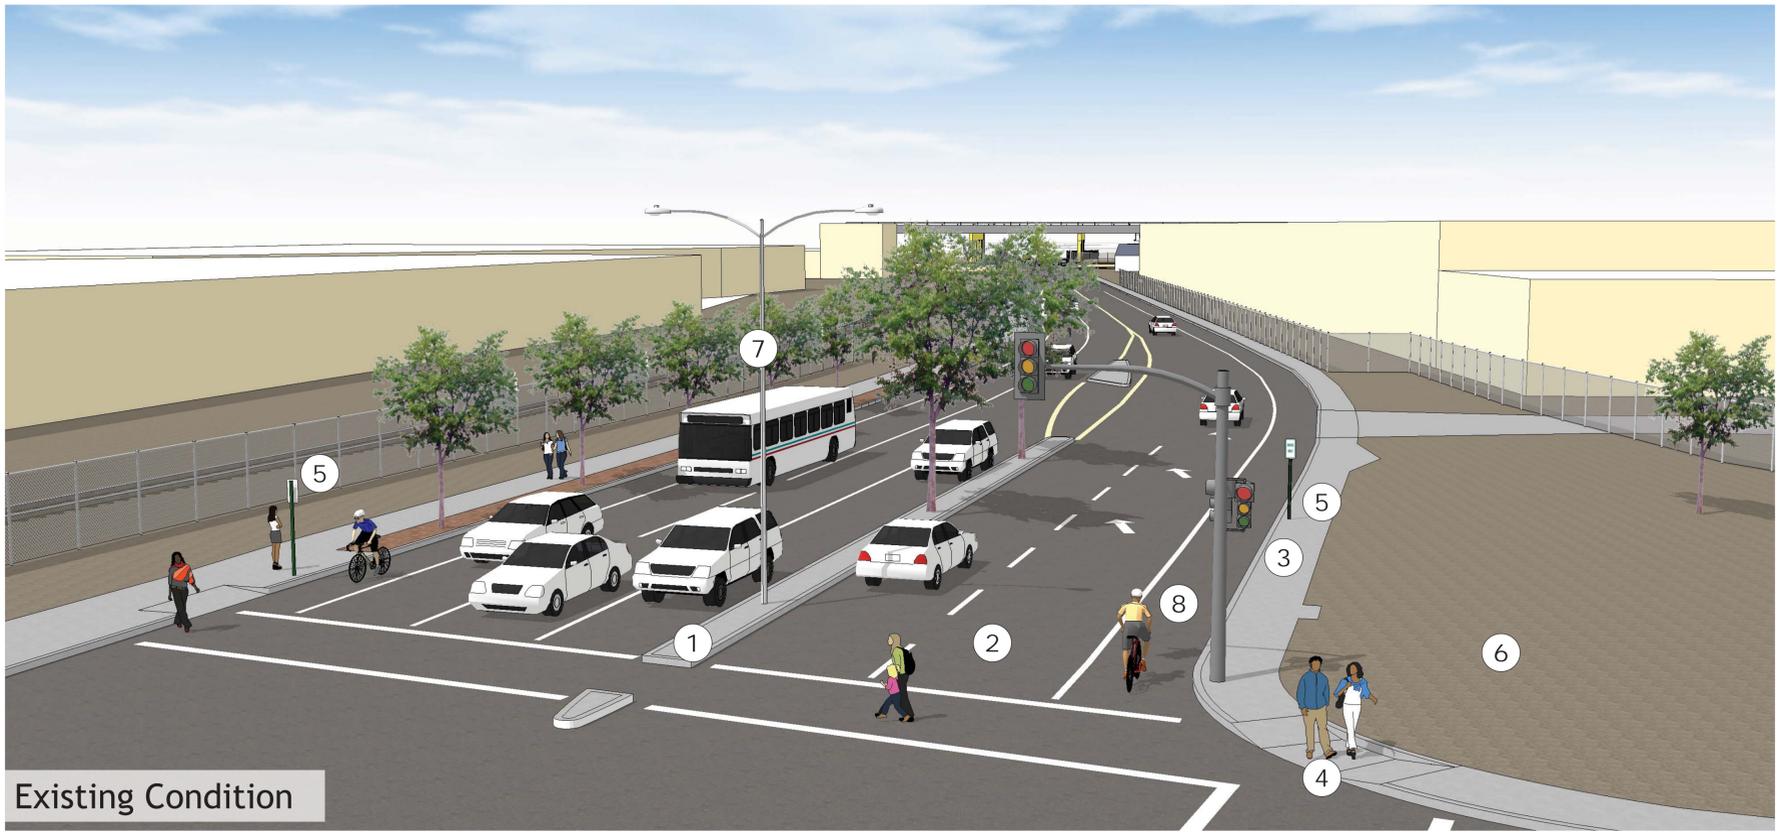
Existing Condition

1. Median narrow and concrete.
2. Roadway wider than needed.
3. 6' sidewalk.
4. Large curb radius.

5. Bus stops unimproved.
6. City-owned area needs improvement.
7. Auto-oriented street lights.
8. Standard bike lanes.

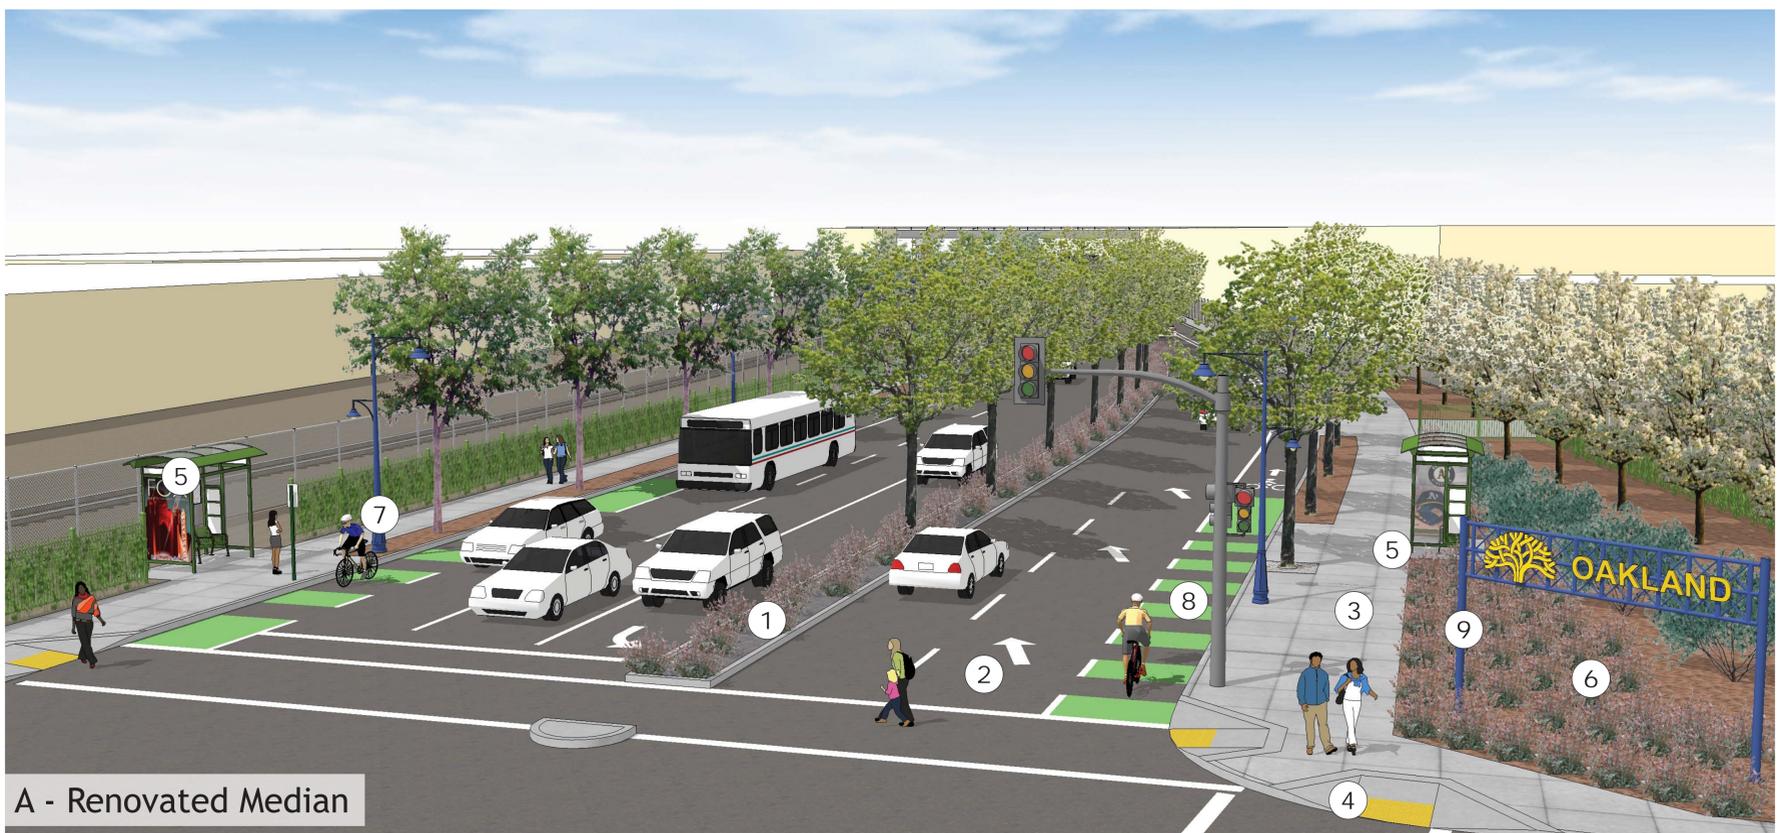
A - Renovated Median

1. Median widened slightly and planted with trees and shrubs.
2. Roadway narrowed slightly to shorten pedestrian crossing distance.
3. Sidewalk widened to 10' and planted with street trees.
4. Curb radius reduced to shorten pedestrian crossing distance.

5. Bus stops improved.
6. City-owned area landscaped and improved.
7. Pedestrian- and auto-oriented street lights.
8. Bike lanes widened and buffered with paint stripe.
9. New gateway sign.

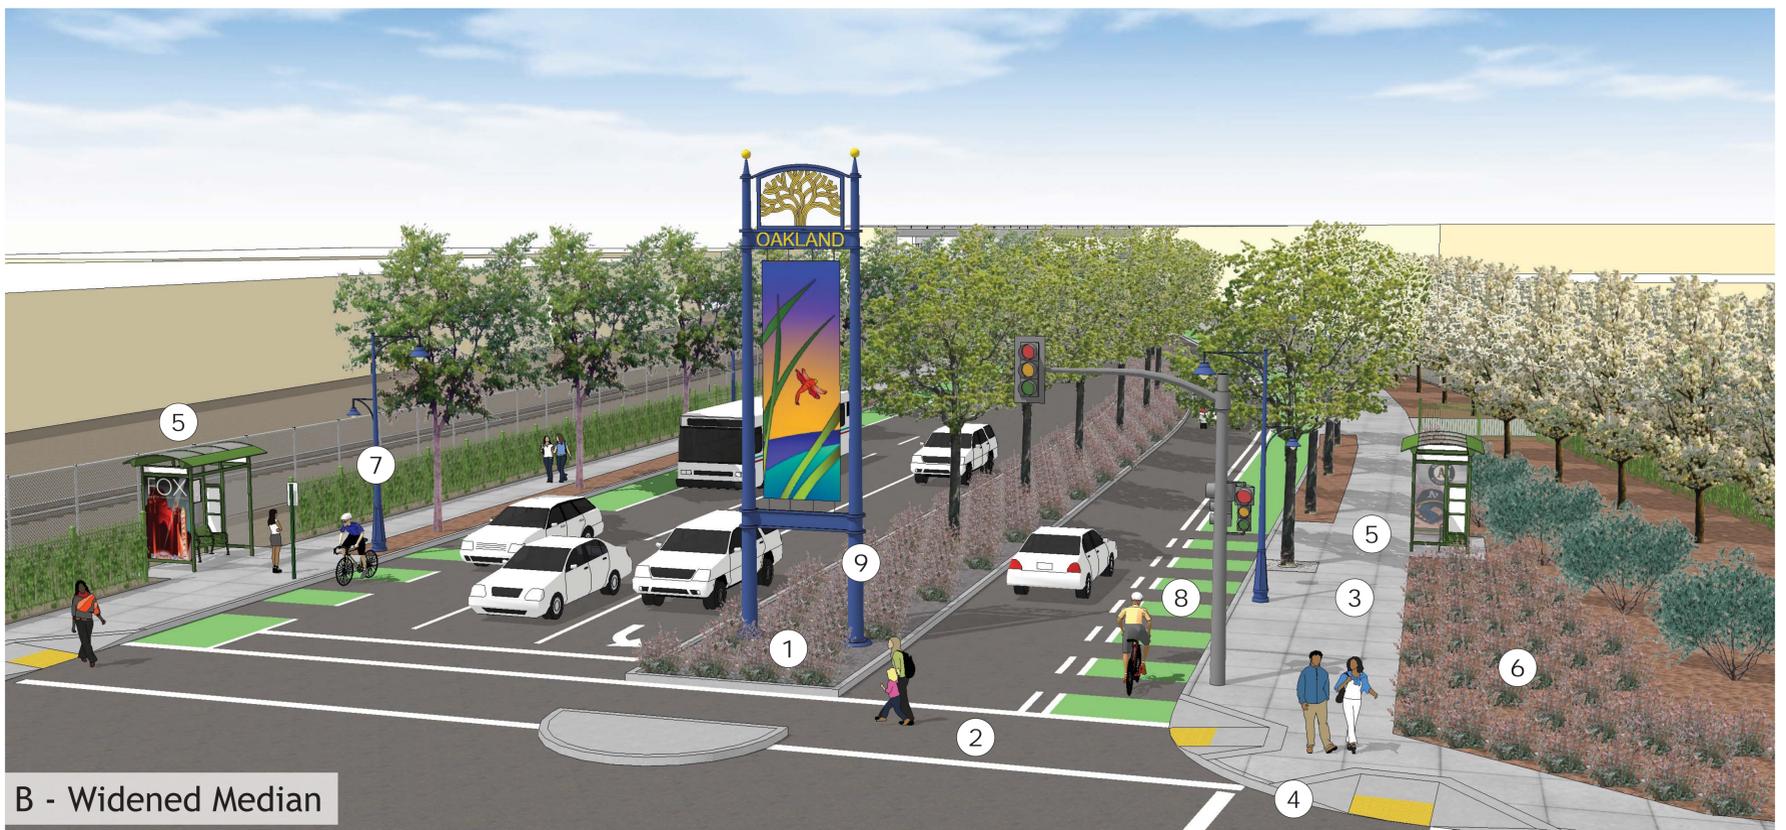
B - Widened Median

1. Median widened and planted with trees and shrubs.
2. Roadway narrowed to shorten pedestrian crossing distance.
3. Sidewalk widened to 10' and planted with street trees.
4. Curb radius reduced to shorten pedestrian crossing distance.

5. Bus stops improved.
6. City-owned area landscaped and improved.
7. Pedestrian- and auto-oriented street lights.
8. Bike lanes widened and buffered with paint stripe.
9. Salvaged Hegenberger Road gateway sign with new banner.
